Property Inspection Report

Report Number: 01-05-208

208 Monroe Street
Carthage, North Carolina 28327

Date of Inspection: Friday, January 5, 2024

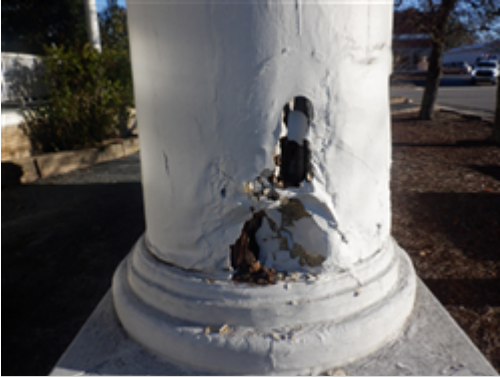
(A2 - 1.1) Porch

The columns have visible areas of decay. The damage could jeopardize the strength of the columns. The decay indicates a history of elevated moisture and or direct water penetration in or around the column area. A licensed general contractor should be consulted for further evaluation, to make necessary repairs. IF these repairs are beyond the scope of the general contractor consult a structural engineer to develop a repair plan for the general contractor to follow.

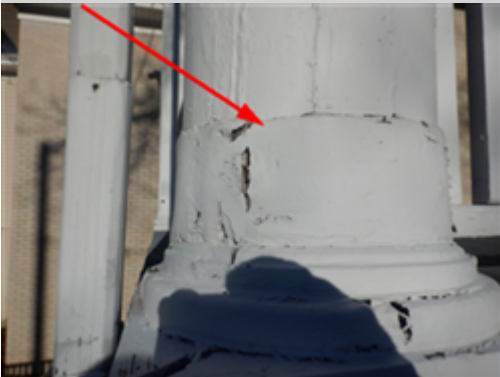
(A2 - 1.2) Porch

Several columns have visible wood filler repairs. Wood filler is used as a temporary repair when wood decay is present. Decay in load bearing columns can result in reduced capacity and structural concerns. Since wood filler repairs have a limited life and depend on the complete removal of all decay, the repairs need further evaluation. The homeowner should be asked for disclosure related to the age/extent of the repair. A licensed general contractor should be consulted for further evaluation and repair/replacement of the columns.

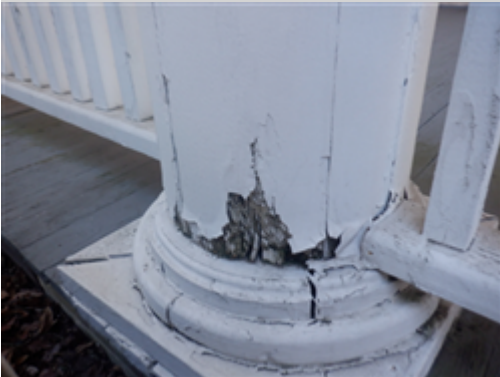
(A2 - 1.3) Porch

Additional photo of damage to columns

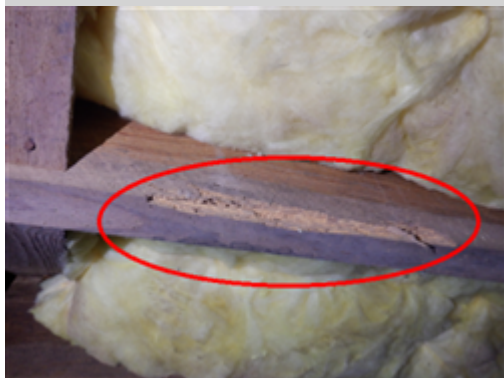
(A3 - 1.1) Main House

The framing components in the foundation areas of the home have been subjected to insect damage typical of wood destroying beetles. The damage is done by the larvae that feed and reduce the wood to a fine powder or mass of small pellets. The larvae can tunnel in the wood for months or years before they emerge as adult beetles. Since the larvae never come to the surface, the damage can be considerable and hidden deep in the center of timber. The damage reduces the overall density and therefore the overall strength of the wood. Several framing components under this home and especially under the front porch have some level of visible damage (beetle exit holes). The inspection of the wood members during a home inspection consists of sounding and direct probing. This method alerts the inspector to possible damage but cannot fully define the extent of the damage. During the inspection, the majority of the damage under this home was thought to be active, with numerous wood members that could be probed. The interior inspection of this home was very limited due to storage/personal items and this limited the overall evaluation of the floors, walls, and doors. An engineer or a licensed general contractor that specializes in historical homes should be consulted to evaluate the framing to determine the extent of the damage and necessary repairs. A licensed pest inspector should also be consulted to determine activity level for the insects and if treatment is required.

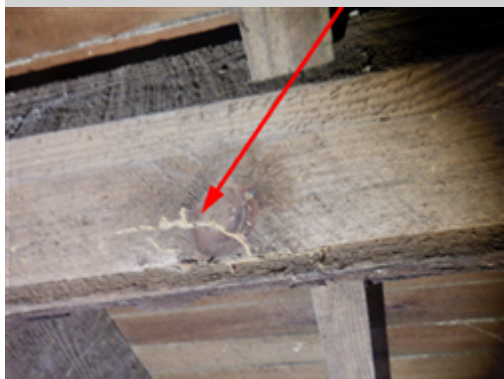
(A3 - 1.2) Main House

A small area of termite activity evidence was noted under the front porch. It was unknown to the inspector if the termites are active. Consult pest control contractor for treatment as needed.

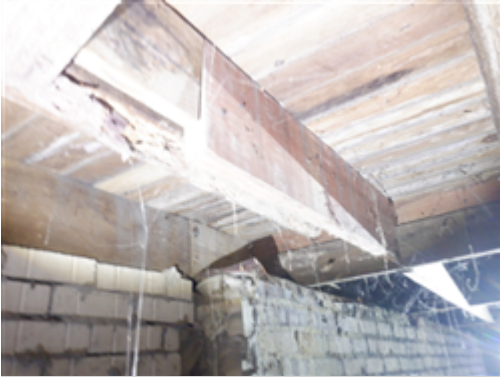
(A3 - 2.1) Porch

The floor framing has been modified, the area of concern was located under the front porch. The framing modifications do not follow standard framing methods that would normally be observed for a framing repairs. A licensed general contractor should be consulted for complete evaluation of the floor system to determine the extent of the concerns and to make necessary repairs to ensure the stability and durability of the floor system.

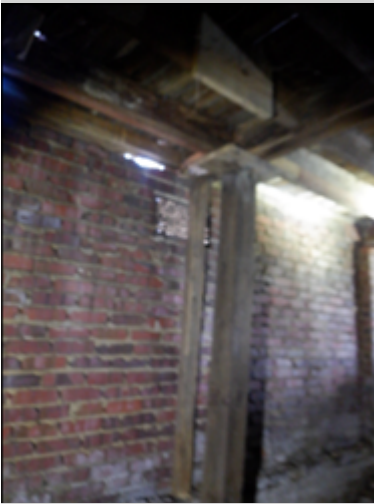
(A3 - 2.2) Porch

Image of supplemental supports that have been added under the porch

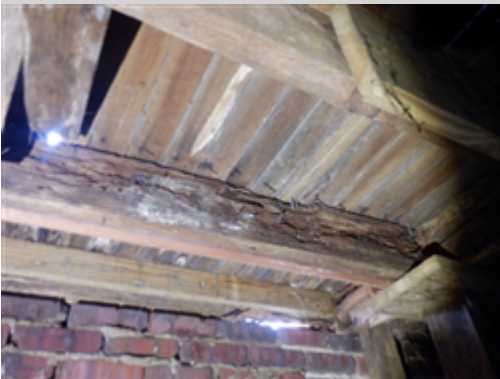
(A3 - 2.3) Porch

Image of decayed framing under front porch

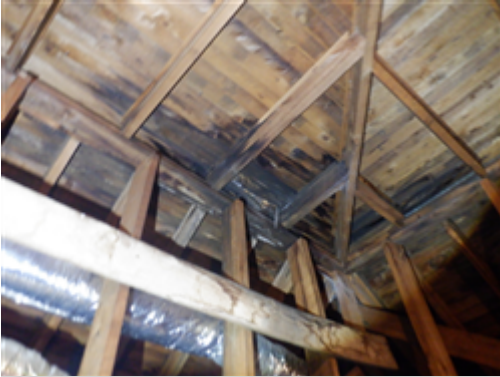
(A6 - 1.1) All Accessible Areas

From the attic, the wood framing components located at the 4 corners where the handrail posts are attached are discolored and decayed. The level of decay indicates a long term leak that could involve hidden areas of damage, the flashing, and the roof covering systems. The area was also wet at the time of the inspection indicating an active leak. A licensed general contractor should be consulted for further evaluation and repair to determine the source of the leak and extent of the damage to ensure the stability of the home and prevent additional damage.

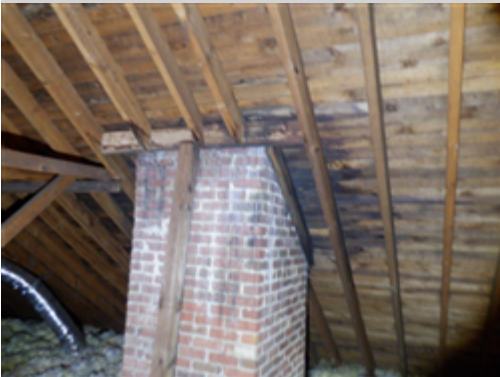
(A6 - 1.2) All Accessible Areas

From the attic, the wood framing components around the chimney are discolored and decayed. The level of decay indicates a history of a long term leak that could involve hidden areas of damage, the flashing, and the roof covering systems. A licensed general contractor should be consulted for further evaluation and repair to determine the source of the leak and extent of the damage to ensure the stability of the home and prevent additional damage.

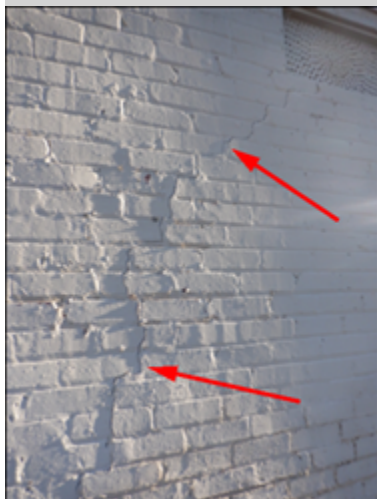
(B1 - 1.1) Main House

Cracks were noted above/below the windows/doors/foundation vents in the brick on the rear of the home. Cracks in brick veneer indicate a deficiency that can change or progress over the life of the home. The cracks on this home were closed at the time of the inspection and presented no visible evidence of progression to the foundation areas, however, the cracks could open or change seasonally. The owners should be asked for disclosure related to the progression, history of repairs, or seasonal changes of the cracks. Even closed or minor cracks can cause consumer or buyer concerns at the time of resell. The buyers should observe the cracks and assess their concerns related to the presence of the cracks, the number of cracks, and possibility of the condition worsening over the life of the home. The cracks should be noted, repaired by a general contractor, and monitored to establish a history of stability. If additional information is needed an engineer should be consulted.

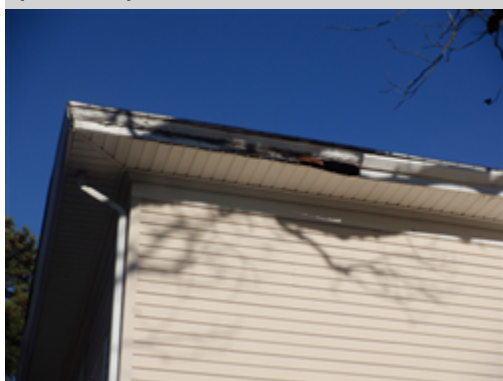
(B1 - 1.2) Main House

The boxing and trim areas were found to have areas of damage/decay related to problems with the built in gutters and roof drainage. Repairs are needed to the boxing and gutter system. A licensed general contractor should be consulted for a complete evaluation of the exterior of the home to determine the extent of the damage to the boxing, trim, and underlying components to ensure the weathertightness of the system.

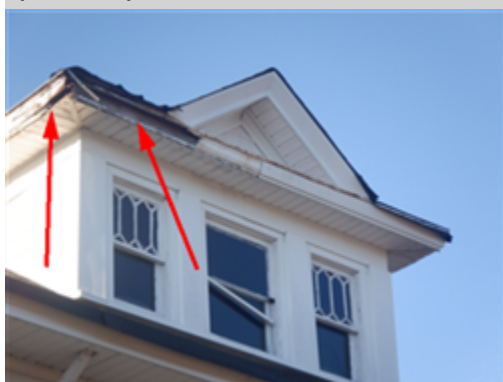
(B1 - 1.3) Main House

Additional photo of decayed fascia

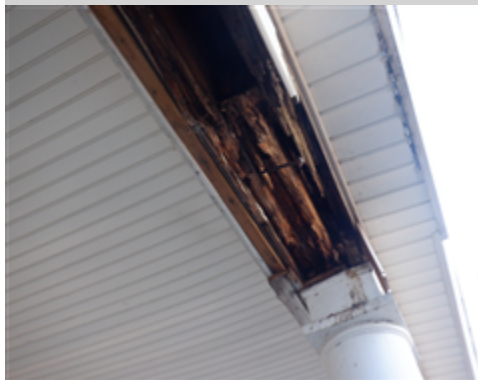
(B1 - 1.4) Main House

Image of decayed framing that supports the roof between columns on the right side of the home. Consult general contractor for evaluation and repair.

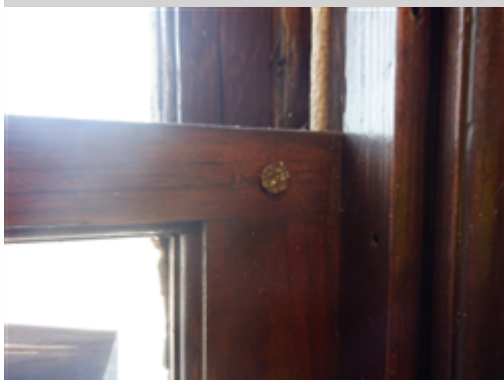
(B2 - 1.1) Windows

Windows appear to be swollen and would not open when nail locks were removed. Consult window restoration specialist for evaluation and repair of all windows to include cracked panes and inoperable sash cords.

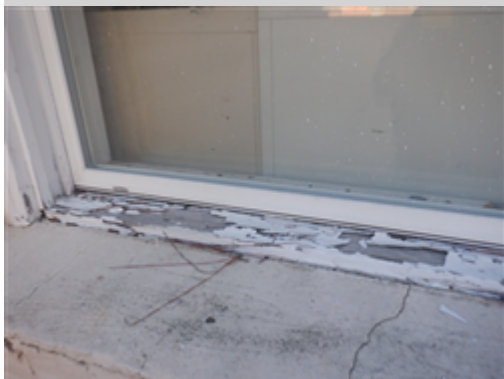
(B2 - 1.2) Windows

Peeling paint is in need of prep and painting to protect bare wood from decay.

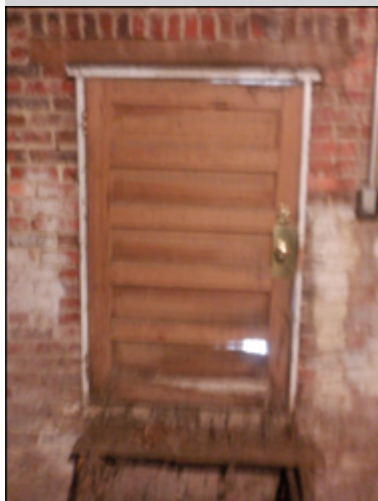
(B2 - 2.1) Door

The door is damaged split/busted in the panel area. The door needs repair/replacement to ensure that the door closes securely and is weather tight. A general repair specialist or licensed general contractor should be consulted for evaluation and repair.

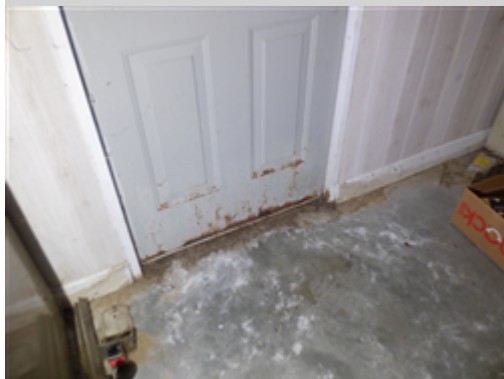
(B2 - 3.1) Door

The door has soft and decayed wood in the trim and frame area and door panel cladding is starting to rust. Water stains and discolorations indicate that the door leaks at the door sill area and around the glass window inserts. Decay and leaking can result in hidden damage and undesirable conditions. A general repair specialist or licensed general contractor should be consulted for evaluation and repair.

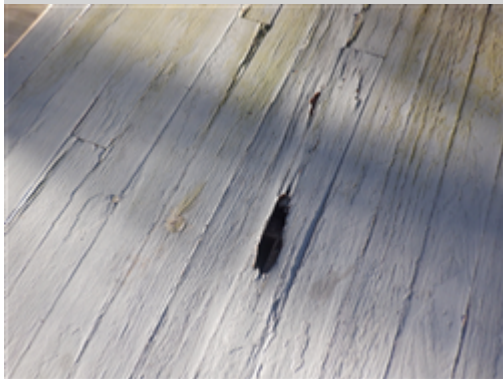
(B3 - 1.1) Porch

The porch was found to be in poor condition and in need of immediate evaluation and repair. The following concerns were noted at the time of the inspection:

1. The decking surface is poor condition in several areas.
 2. The porch outer band is decayed from direct water penetration on the right side of the home which can lead to movement and failure
 3. Scab repairs have been made to the floor framing
 4. Evidence of powder post beetles and termites was noticed on the framing of the porch
 5. Several handrail sections are no longer attached and in need of repair or replacement
- A licensed general contractor should be consulted for a complete evaluation of the deck step system and to make necessary repairs to ensure safe and functional use of the deck.

1. The decking surface is poor condition in several areas.
2. The porch outer band is decayed from direct water penetration on the right side of the home which can lead to movement and failure
3. Scab repairs have been made to the floor framing
4. Evidence of powder post beetles and termites was noticed on the framing of the porch
5. Several handrail sections are no longer attached and in need of repair or replacement

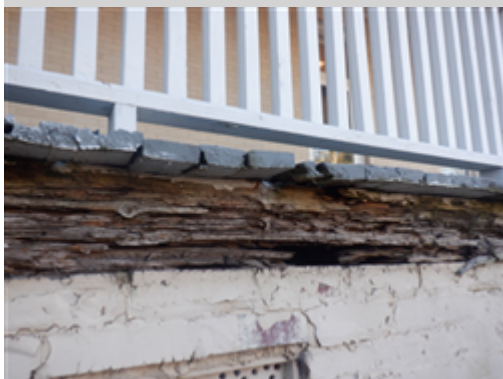
(B3 - 1.2) Porch

Image of decayed framing band and decking boards

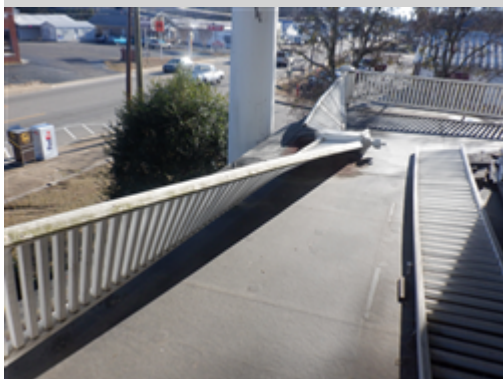
(B3 - 1.3) Porch

Image of damaged handrails on second story porch

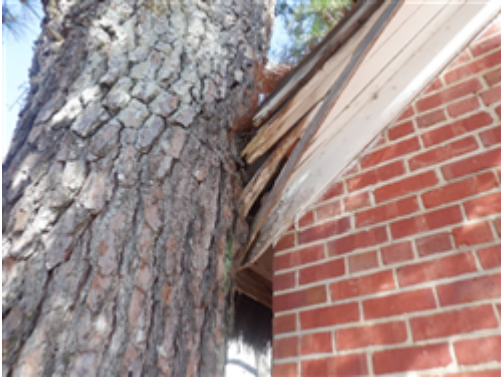
(B5 - 1.1) Historical Trees

Tree at the right rear of the garage has made contact with and is damaging the eve of the building. Movement of the tree will create ongoing damage and eventually failure of the brick. Consult tree service contractor for evaluation and removal.

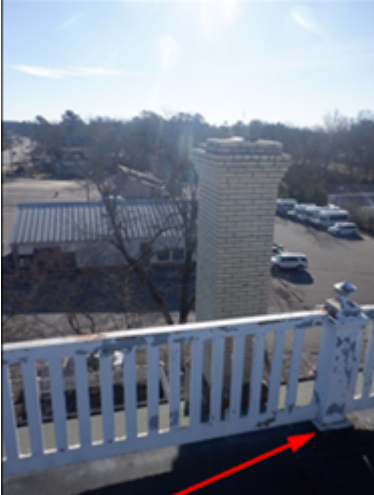
(C1 - 1.1) Main House

The flat roof surface was noted to be spongy or weak where the railings are attached. This could indicate a history of leaking and an underlying problem with the roof decking. A licensed general contractor should be consulted for a complete evaluation to determine the significance of the concerns and to make necessary repairs. At the time of the repair, the roof structure should be evaluated for possible hidden damage.

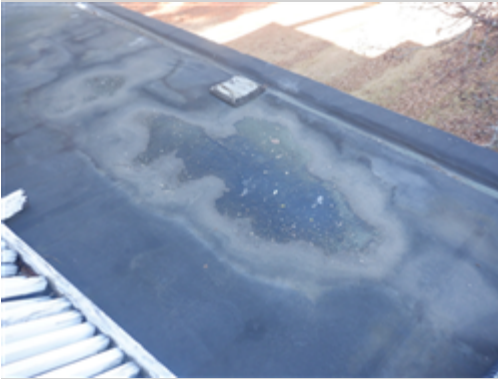
(C1 - 1.2) Main House

Evidence suggests that water has been standing on the roof surface. Improper roof drainage can result in leaks and overloading of the roof system. A licensed general contractor should be consulted for a complete evaluation to determine the significance of the concerns and to make necessary repairs. At the time of the repair, the roof structure should be evaluated for possible hidden damage.

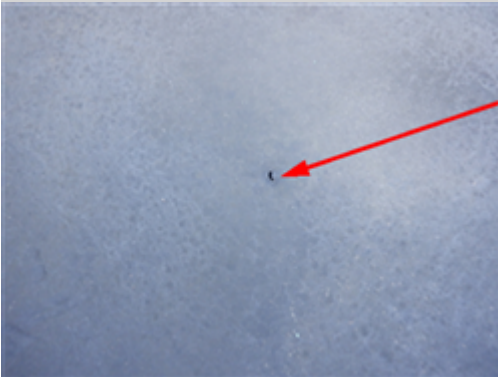
(C1 - 1.3) Main House

Visible holes were noted in the rubber membrane

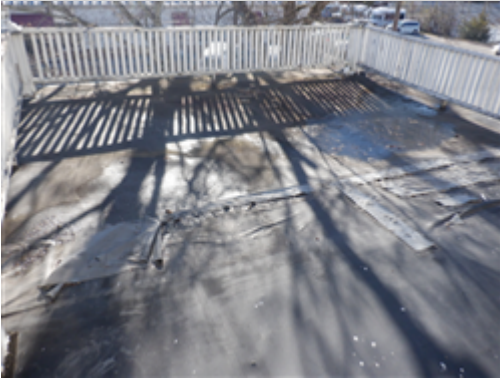
(C1 - 1.4) Main House

The flat roof surface was noted to be spongy or weak at seam locations. This could indicate a history of leaking and an underlying problem with the roof decking. A licensed general contractor should be consulted for a complete evaluation to determine the significance of the concerns and to make necessary repairs. At the time of the repair, the roof structure should be evaluated for possible hidden damage.

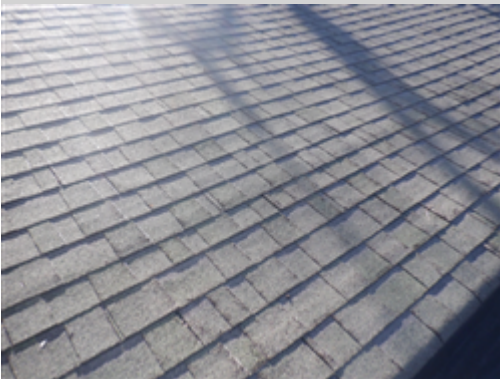
(C1 - 2.1) Main House

The shingles have visible signs of deterioration such as tab shrinkage, low ballast, and exposed base matt that indicate that they are approaching the end of their service life. Damaged shingles are in need of replacement. A licensed roofing contractor should be consulted for a complete evaluation of the roof covering and flashings system to make necessary repairs to ensure the weathertightness of the roof covering system. At the time of the repair, the roofer may be able to answer questions related to the life expectancy of the roof covering system.

The shingles have visible signs of deterioration such as tab shrinkage, low ballast, and exposed base mat that indicate that they are approaching the end of their service life. Damaged shingles are in need of replacement. A licensed roofing contractor should be consulted for a complete evaluation of the roof covering and flashings system to make necessary repairs to ensure the weathertightness of the roof covering system. At the time of the repair, the roofer may be able to answer questions related to the life expectancy of the roof covering system.

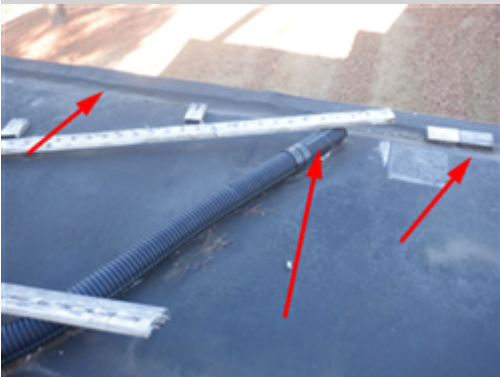
(C2 - 1.1) Main House

Downspout extensions from the upper roof are overwhelming the built in gutters and overflowing causing decay to the fascia. Consult general contractor for evaluation and repair.

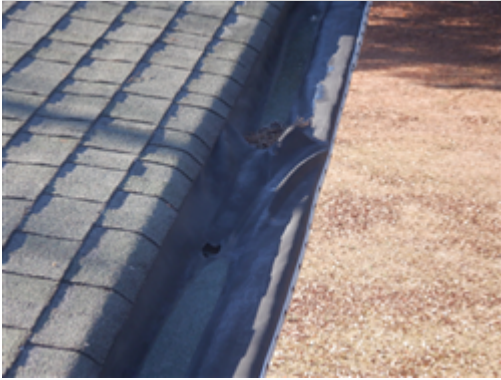
(C2 - 1.2) Main House

The roof gutters for this home are built into the roof line. The gutter boxes are lined with rubber. The rubber liner was noted to be deteriorated in several locations and in need of repair/replacement. The gutters have had a history of leaking over the life of the home. . A licensed general contractor should be consulted for a complete inspection of the gutter boxes and the rubber liner.

The roof gutters for this home are built into the roof line. The gutter boxes are lined with rubber. The rubber liner was noted to be deteriorated in several locations and in need of repair/replacement. The gutters have had a history of leaking over the life of the home. A licensed general contractor should be consulted for a complete inspection of the gutter boxes and the rubber liner.

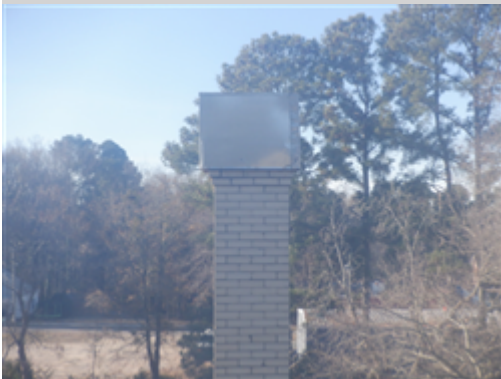
(C4 - 1.1) Main House

One of the chimneys has been capped to prevent water intrusion but the deterioration of the interior brick needs evaluation and repair or removal. Consult general contractor for evaluation and options for repair.

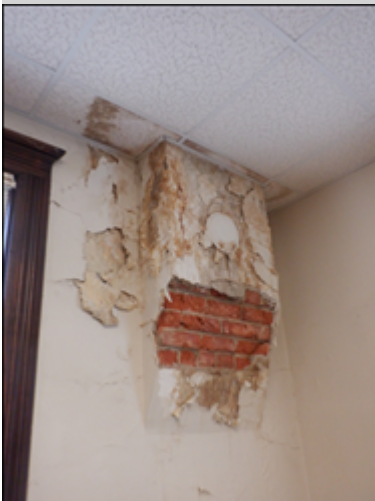
(C4 - 1.2) Main House

Image of deterioration of the brick chimney from interior

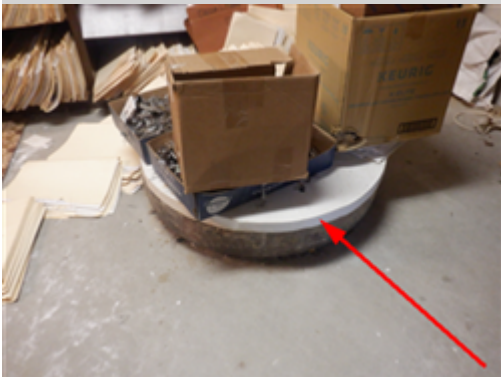
(D1 - 1.1) Crawl Space

This home has a private well that is no longer in use in the basement. Determining if the water supply is potable or of good quality is beyond the scope of the home inspection. Wells require regular maintenance and can become contaminated with bacteria or other contaminants. It is recommended that the buyer consult the local health department or a licensed well contractor for system evaluation and testing.

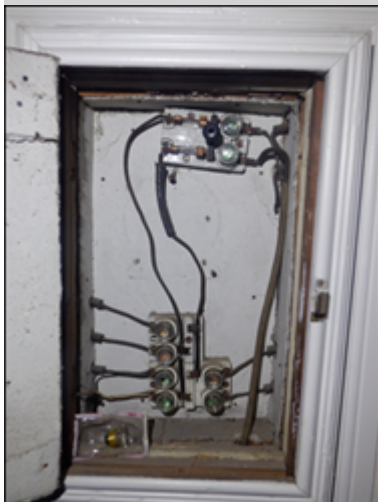
(E3 - 1.1) Distribution Panel #1

Electrical modifications have been made to add circuits and upgrade electrical service panel boxes; however, branch wiring in many locations is still the original knob and tube wiring. The following deficiencies were noted during the inspection: K&T is covered with insulation and insulated ducts; K&T was noted to enter wall areas. A licensed electrical contractor should be consulted for a complete evaluation of the electrical system of the home to outline repairs for immediate safety concerns and hazardous conditions. At the time of the repair the contractor should be asked to recommend the best solution for modern upgrades if they are not required to correct current conditions.

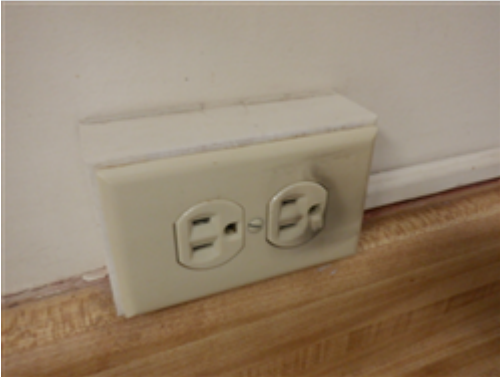
(E5 - 1.1) Kitchen

The receptacle has visible damage that could indicate a short or history of arcing. A licensed electrical contractor should be consulted for a complete evaluation to determine the significance of this concern and make necessary repairs to correct defects and prevent safety hazards.

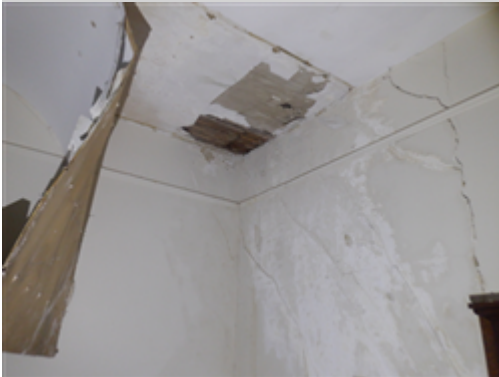
(H1 - 2.1) All Rooms

The historical ceilings and walls have crack lines that indicate that plaster is loose from the lathe in several rooms throughout the home. Repair is needed to prevent system failure. A plaster repair specialist should be consulted to evaluate the ceiling and determine necessary repairs.

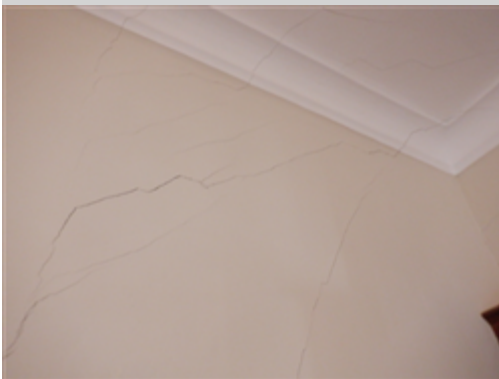
(H1 - 2.2) All Rooms

Additional photo of cracked plaster

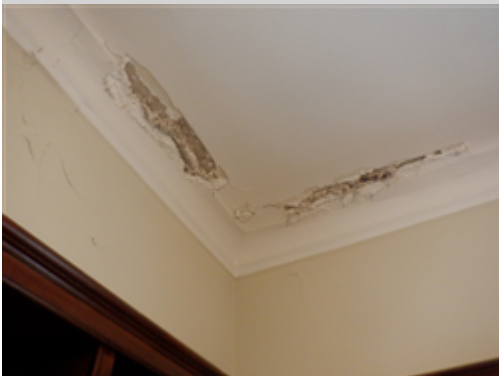
(H1 - 2.3) All Rooms

Additional photo of damaged plaster from water damage due to the roof leaks

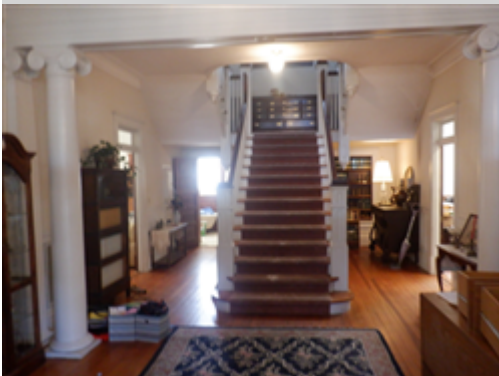
(H1 - 2.4) All Rooms

During the inspection, loose paint chips were noted on the interior wood trim in several areas throughout the home. This home was built in a time period where paint was manufactured with lead, referred to as lead based paint. Since 1978, it has been determined that lead paint chips and improperly maintained lead painted surfaces pose risk factor to families especially families with small children. The testing and inspecting for the absence or presence of lead based paints is beyond the scope of the home inspection, however, it is recommended that you visit the EPA website to evaluate your level of concern and consult a specialist for testing.
(<https://www.epa.gov/lead/protect-your-family-lead-your-home>)

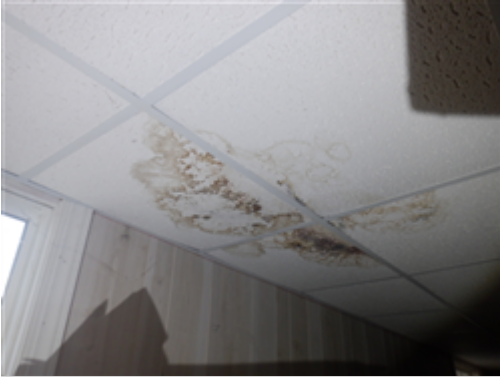
(H1 - 3.1) Basement

Stains on the ceilings indicate a history of a leak. At the time of the inspection it was not possible to determine if the condition was due to an active or past occurrence. Further investigation by a repair specialist and owner disclosure is recommended. Refer to the XXX section of the report.

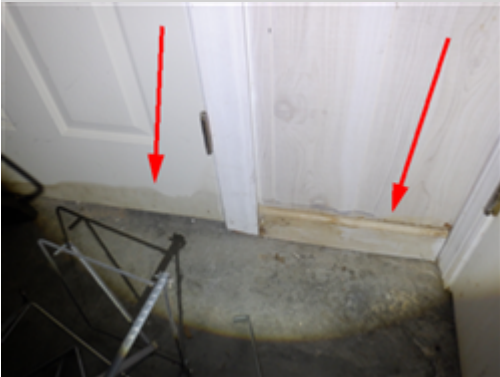
(H1 - 3.2) Basement

The baseboards have heavy water stains at the floor level. An invasive inspection is needed to determine the source of the water penetration and the extent of the damage. A licensed general contractor should be consulted for a complete evaluation to determine the significance of this concern and make necessary repairs.

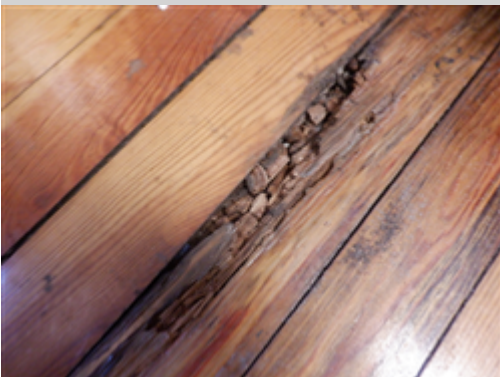
(H2 - 1.1) Kitchen

Image of decayed wood flooring possibly from an old refrigerator leak. Consult hardwood flooring contractor for evaluation and repair.

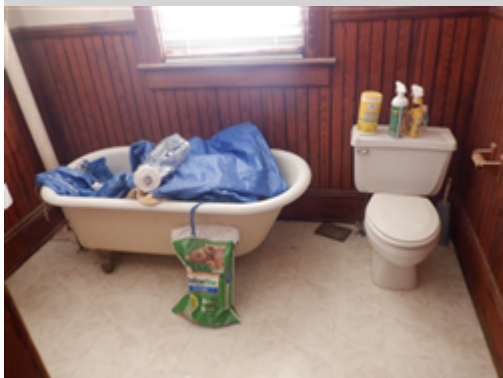
(H3 - 1.1) Bathroom #1

Water was turned off to the tub and toilet. The functionality is not known or why the valves are off. Consult plumber for evaluation and repair as needed.

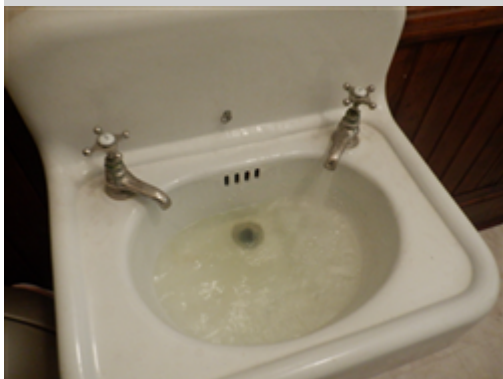
(H3 - 2.1) Bathroom #2 upstairs

The sink drain was noted to be slow. A slow drain could indicate a clogged line or an underlying problem with the drain/waste/vent system. A licensed plumbing contractor should be consulted for evaluation and repair to ensure proper service.

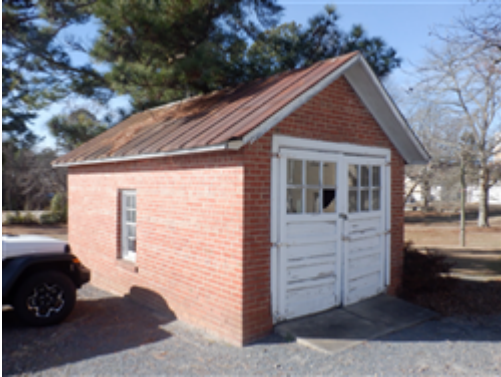
(H4 - 1.1) Garage

Garage doors were locked and the structure could not be entered. Several window panes are broken and need to be replaced. The metal roof is in fair condition. The structure appears to be sound but the tree at the right rear corner is damaging the roofline. Consult tree service to remove tree to protect the structure. Once access is granted consult general contractor for interior inspection for leaks and areas of damage that may need repair.
