Neal Smith Engineering, Inc.

February 15, 2024

Subject: **Structural Inspection**
208 Monroe Street
Carthage, North Carolina
NSE Project #2400511

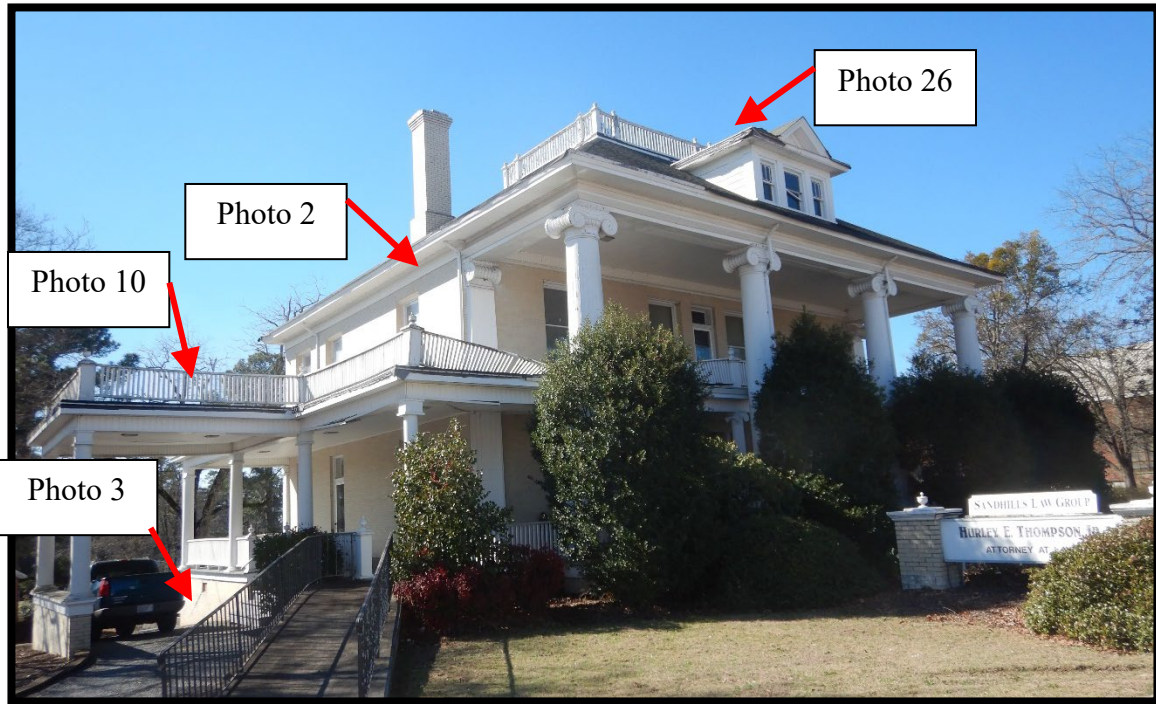
Photo #1 - This is the front of 208 Monro St.

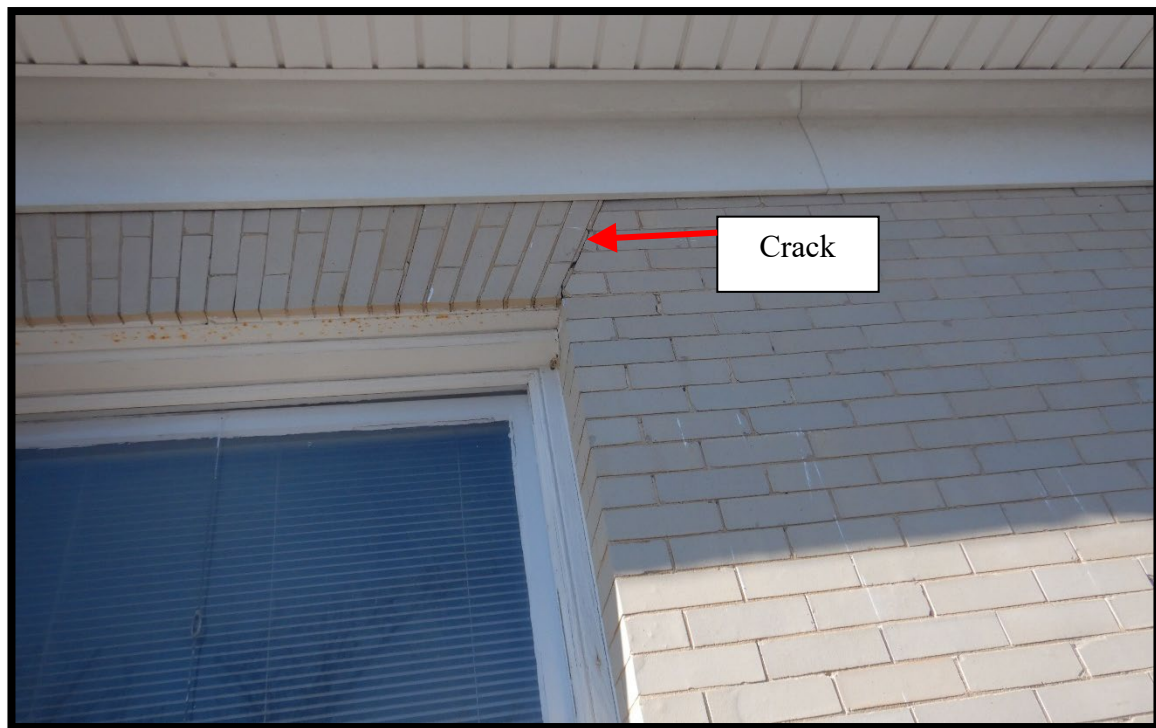
Photo #2 - This is a photo of a brick crack at a window.

The main foundation is in good condition. There are a few minor cracks that can be grouted or caulked. No significant foundation repair is required.

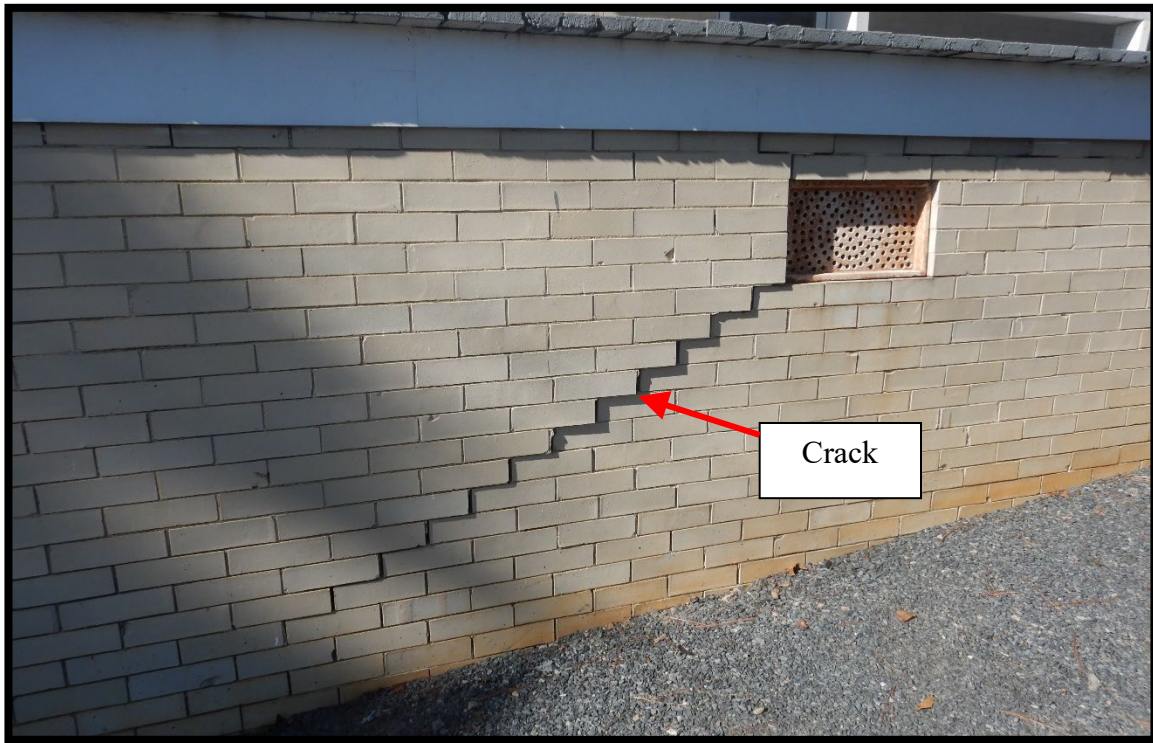
Photo #3 - This inside of this wall is in photo 23. The brick is single wythe.

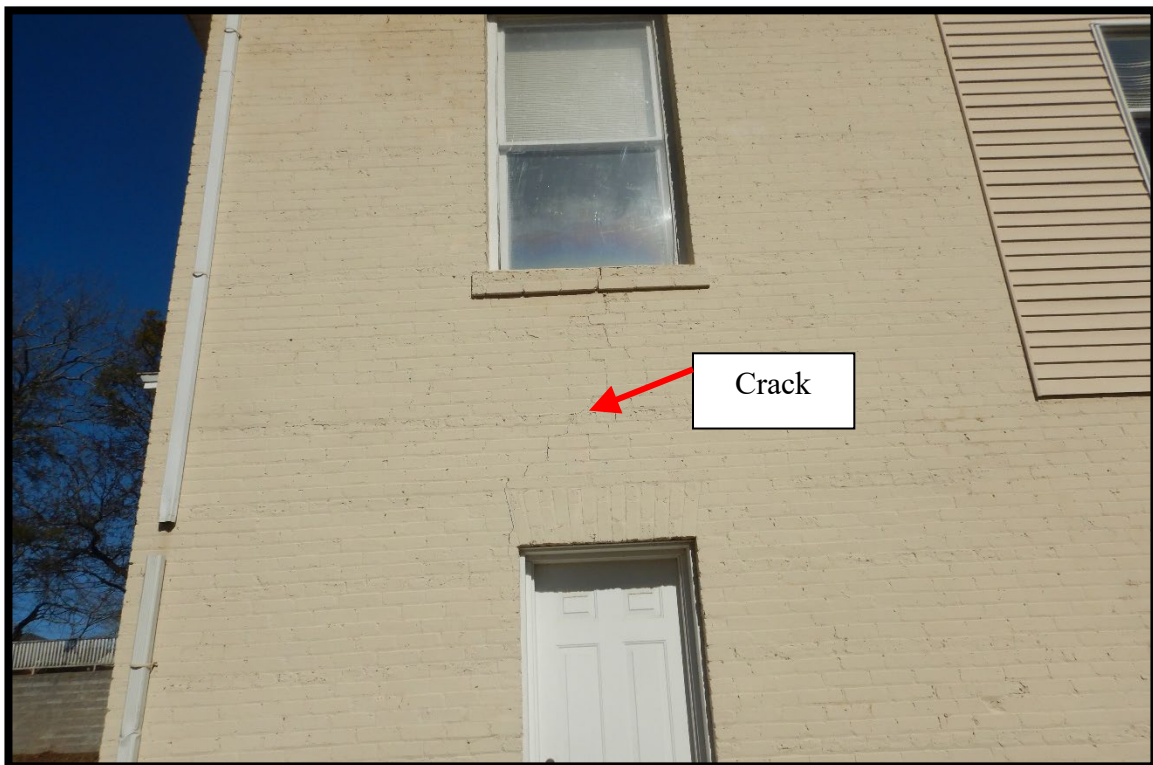
Photo #4 – Minor brick cracks at the rear elevation.

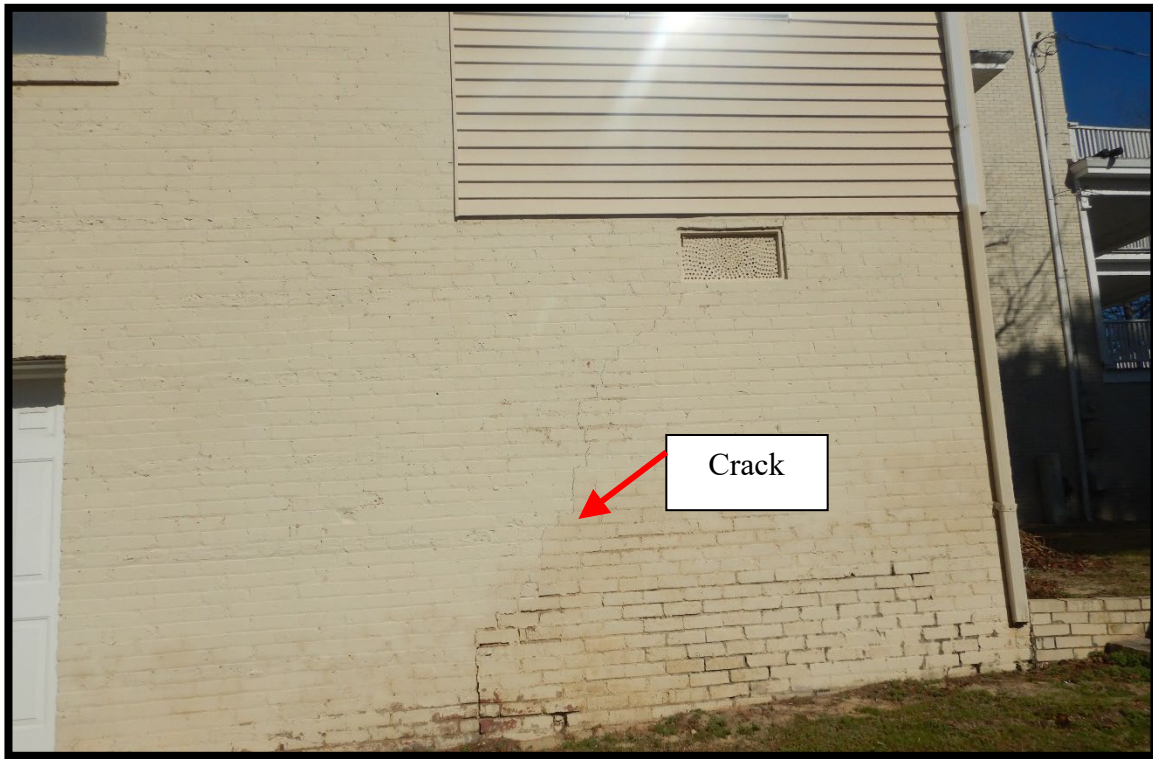
Photo #5 - Minor brick cracks at the rear elevation.

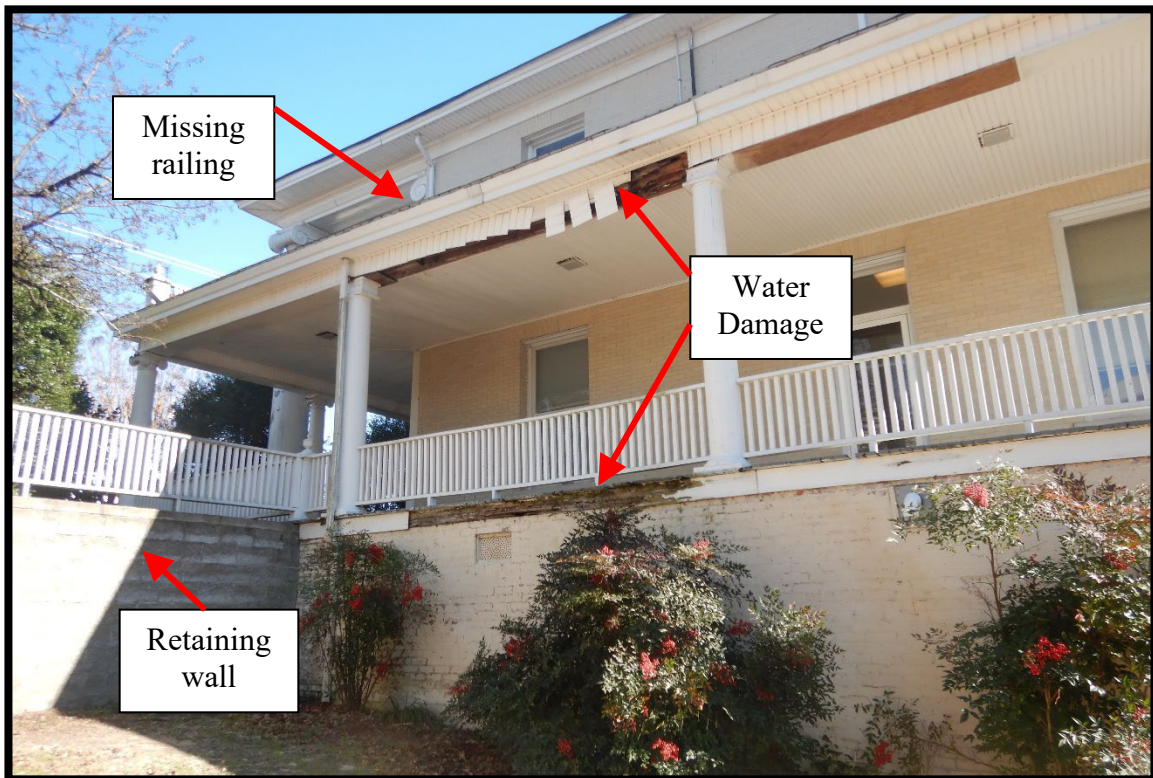
Photo #6 - This is the right side of the structure. The railing is missing and there is severe water damage to the wood structure. This retaining wall is not original.

Many of the railings are already removed. Some that remains is not stable. Most of it, if not all, should be replaced to ensure proper connection to the roof members.

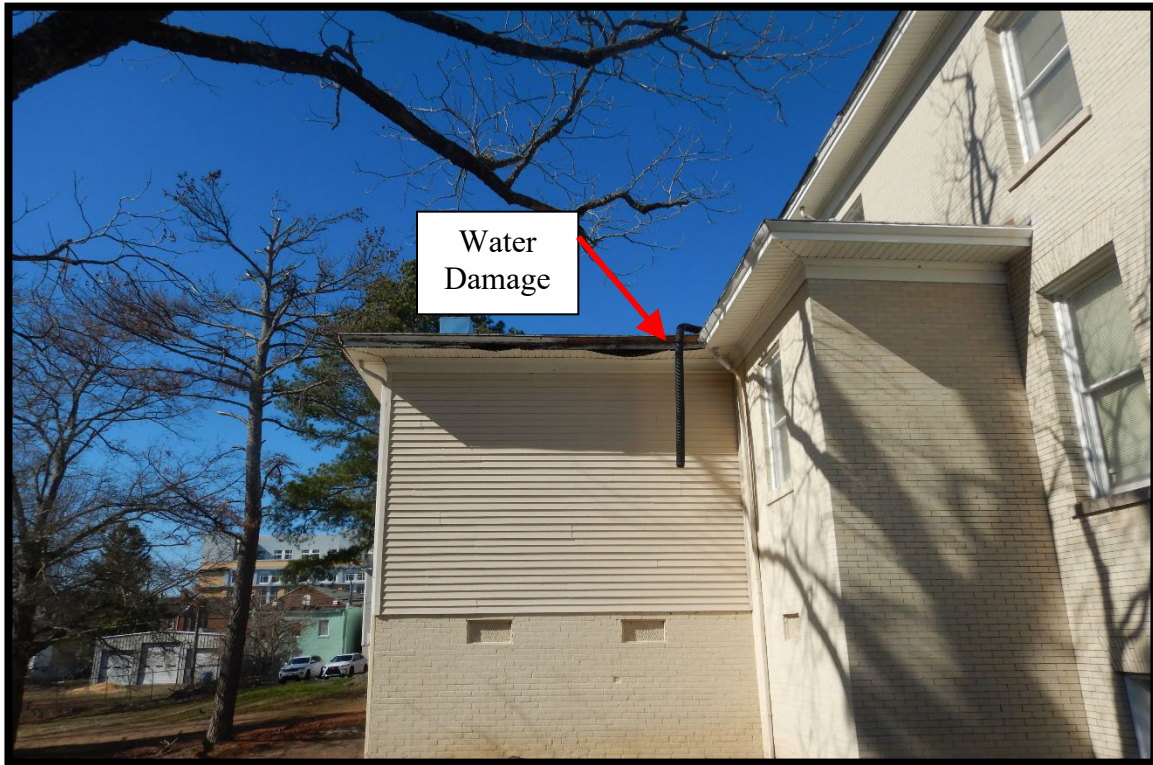
Photo #7- This is water damage at the rear left side.

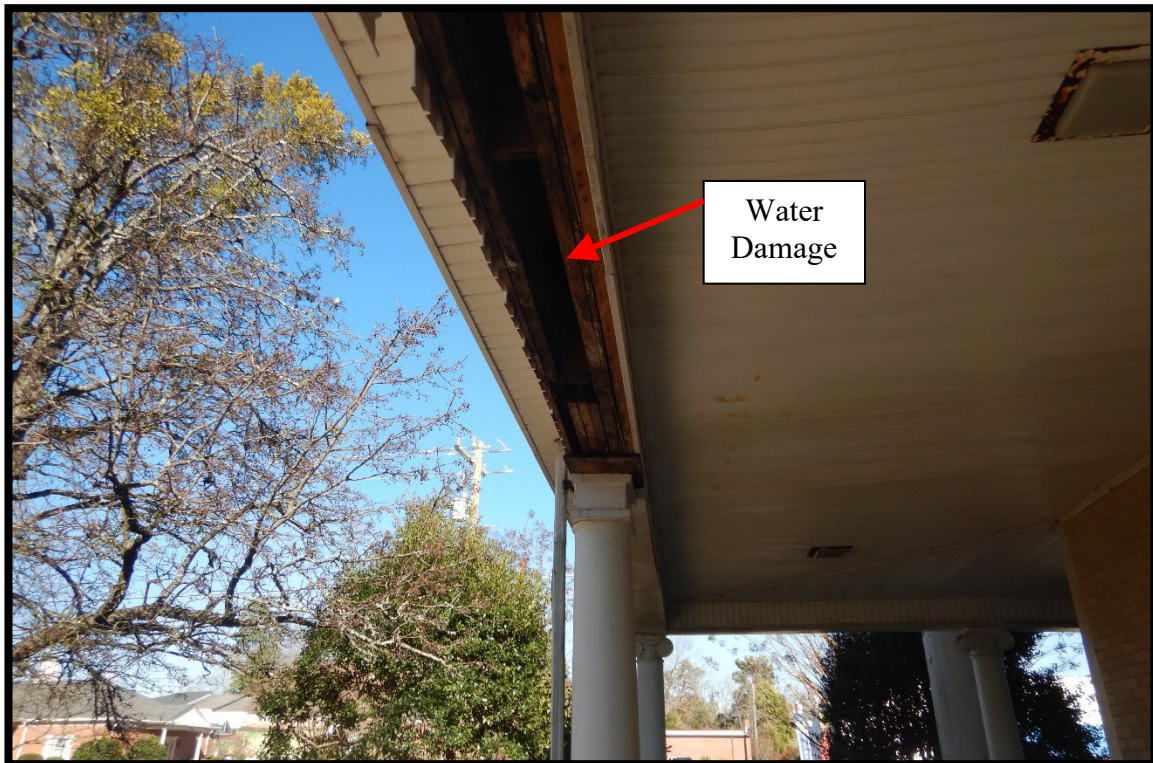
Photo #8 - This is the same water damage in photo 6.

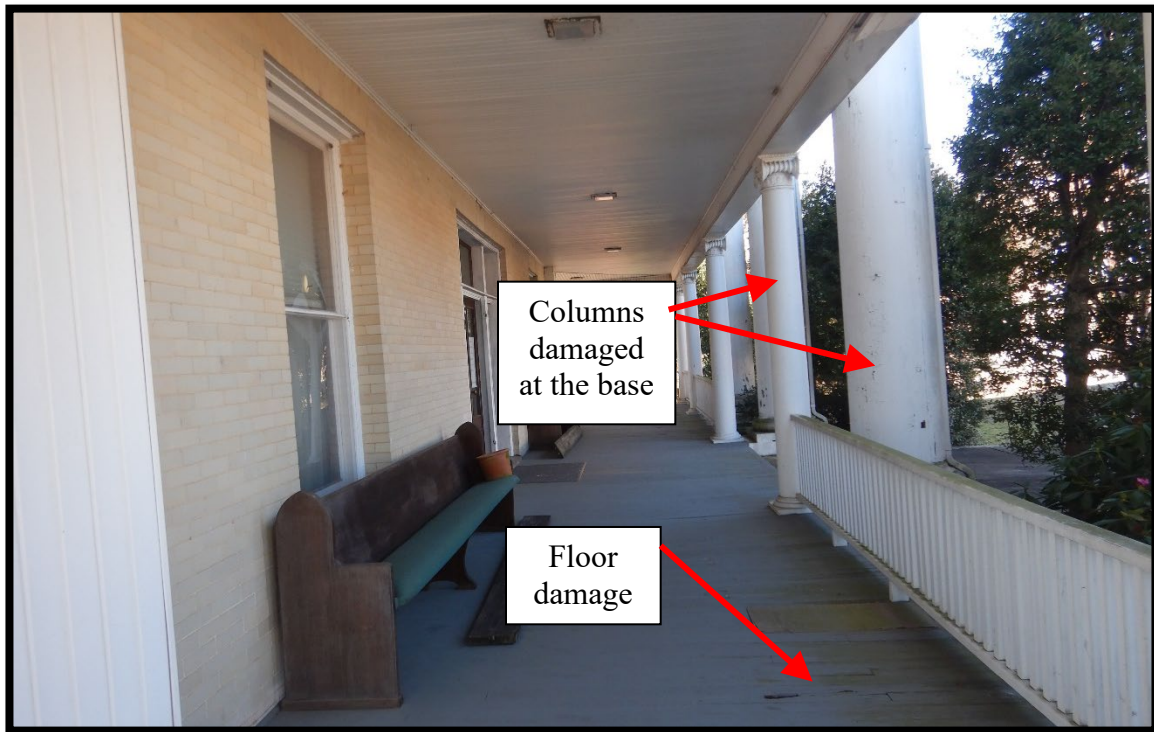
Photo #9 - This is a photo of the front porch. There is damage to the base of the large columns in front and damage to the tongue and groove deck.

The damage to the large columns out front can be repaired. They do not support much weight. They are made with tongue and groove wood members. There are companies that specialize in restoration that can handle this repair.

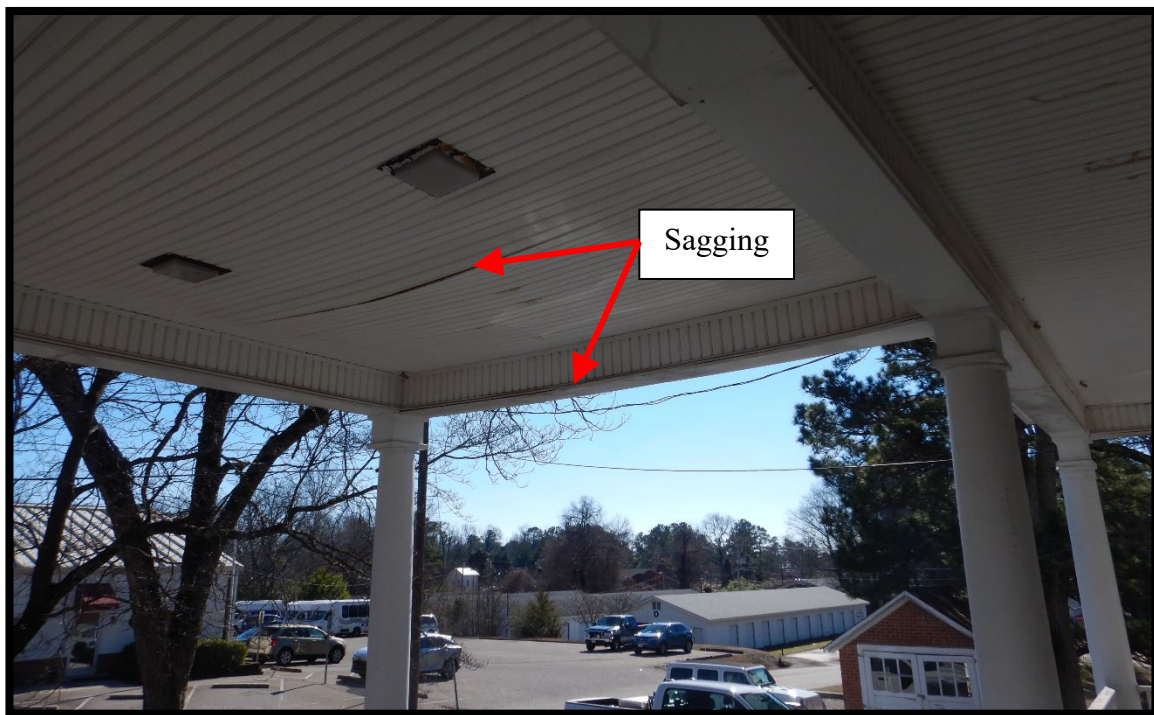
Photo #10 – The cover on the left side is sagging and there is likely heavy hidden water damage.

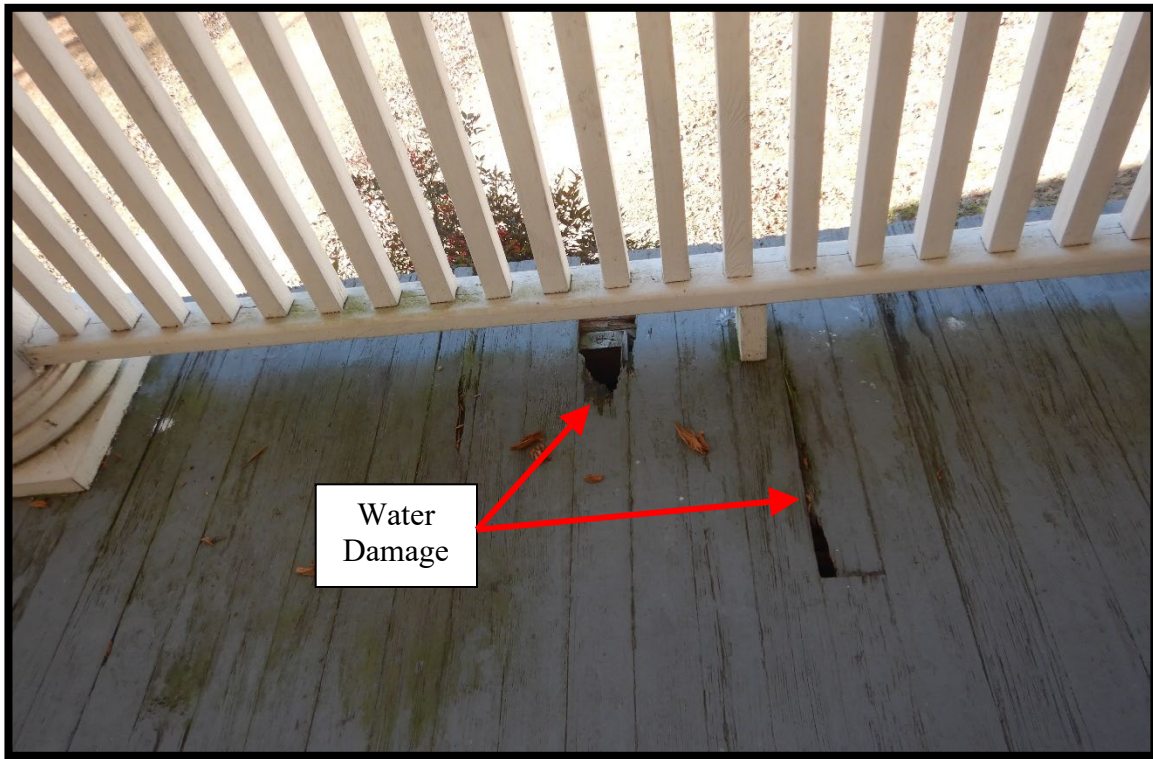
Photo #11 – Damage to the front porch decking.

The additional supports shown under the porches were added to keep from repairing the water damaged wood below. Damaged framing and deck members should be repaired.

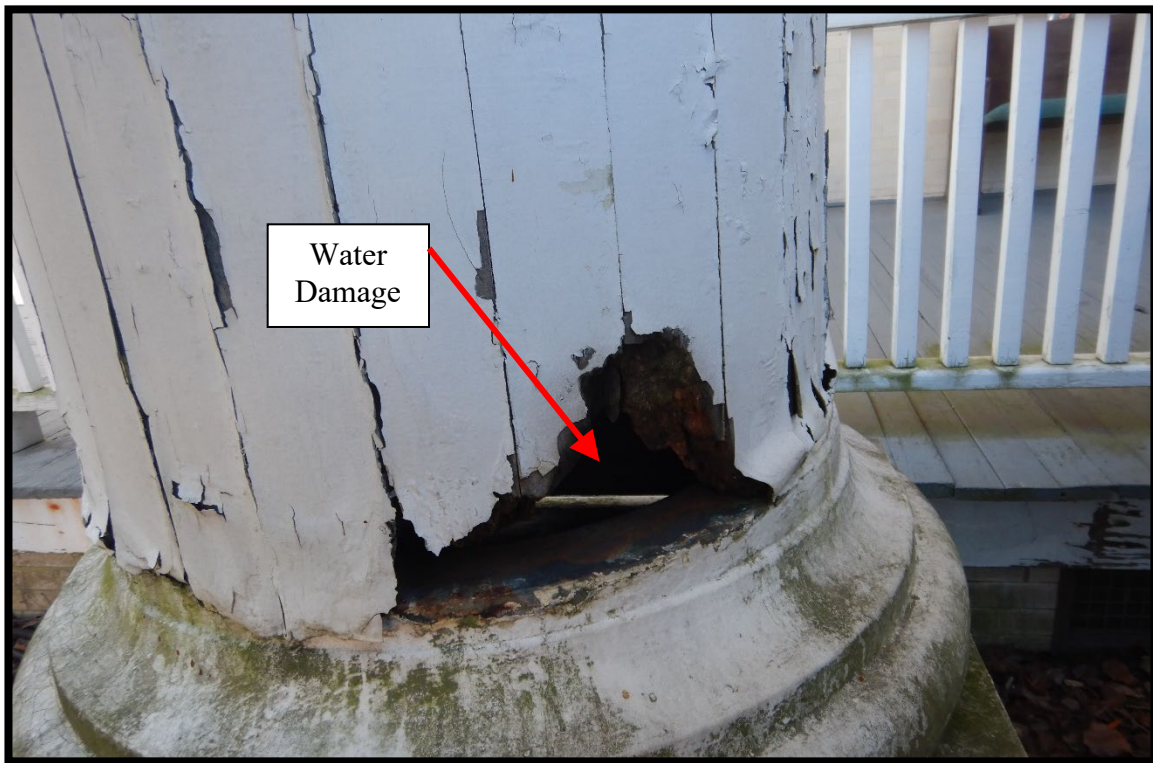
Photo #12 – Severe column water damage, but appears to be limited to the base.

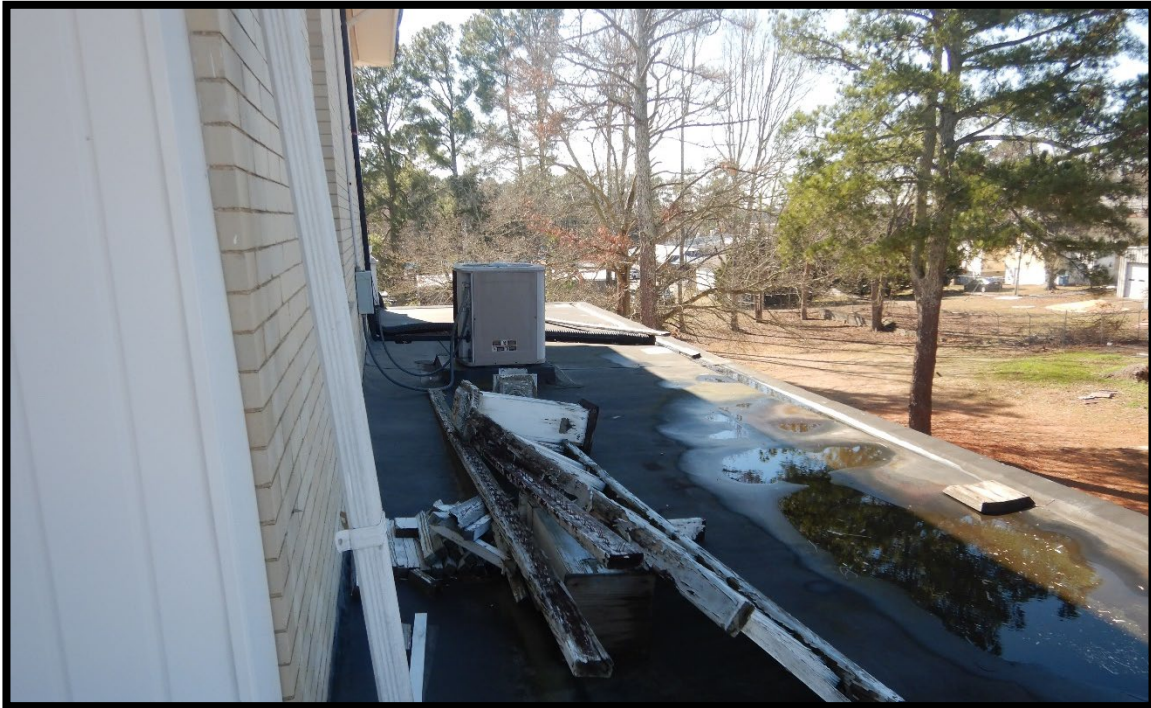
Photo #13 – This is the deck with the missing rail in photo 6. There is likely heavy hidden water damage.

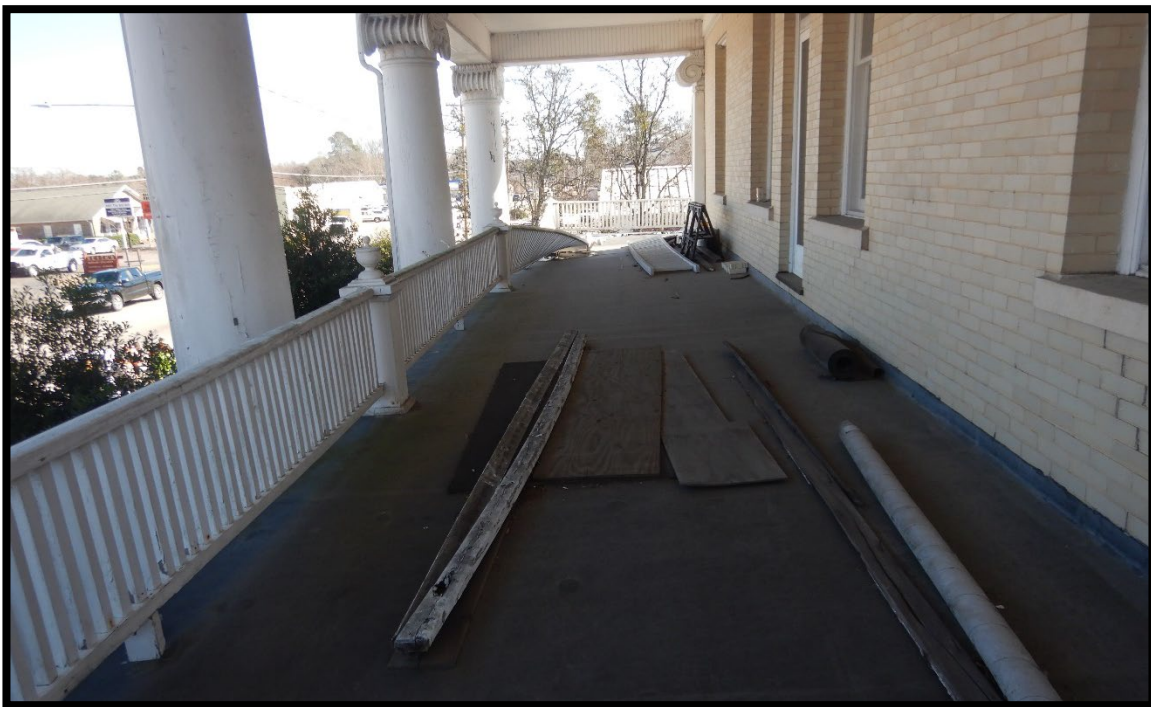
Photo #14 - This is the upper porch along the front. The porches were covered with an EPDM membrane roof approximately 40 years ago. There is likely heavy hidden water damage.

The EPDM rubber roofs need replacing as well. They should be replaced with a TPO membrane roof instead. The TPO membrane will last longer and will reflect light as well keeping the structure cooler. There is likely significant water damage under the existing EPDM roof. After the roof is removed, the contractor will be able to evaluate and repair any damaged wood.

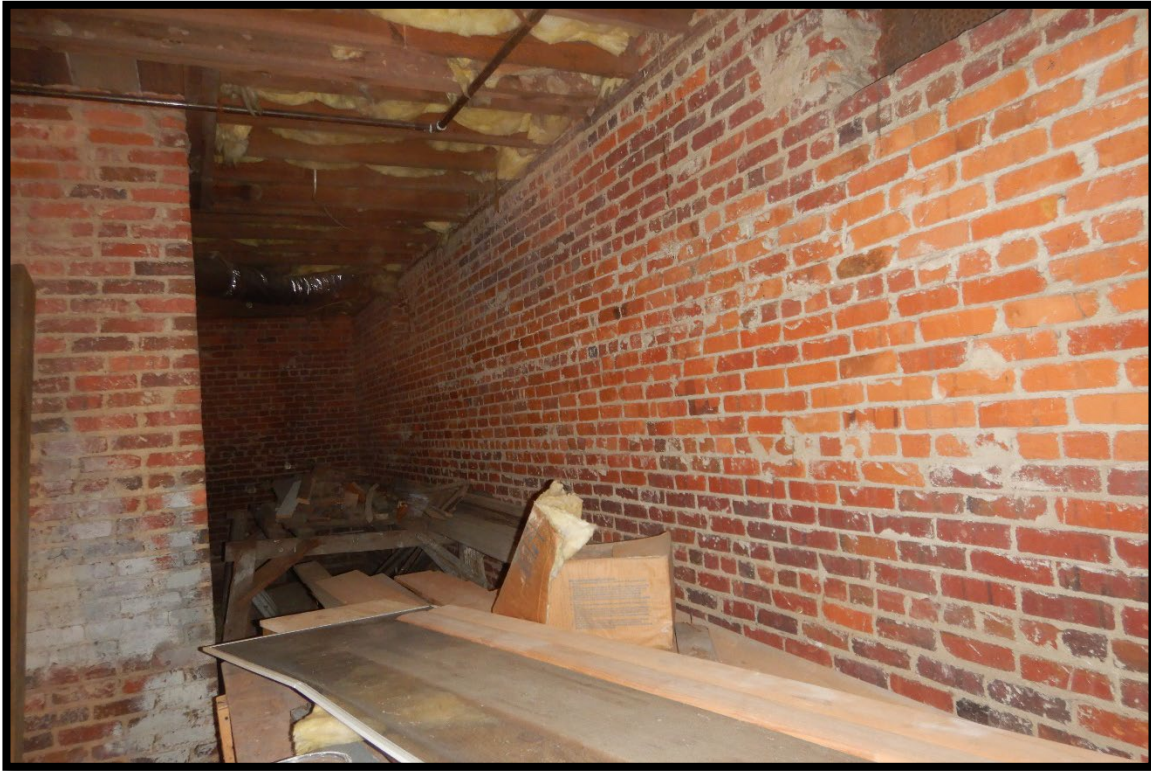
Photo #15 - This is the main structure basement foundation along the front. The walls are 12" thick solid brick.

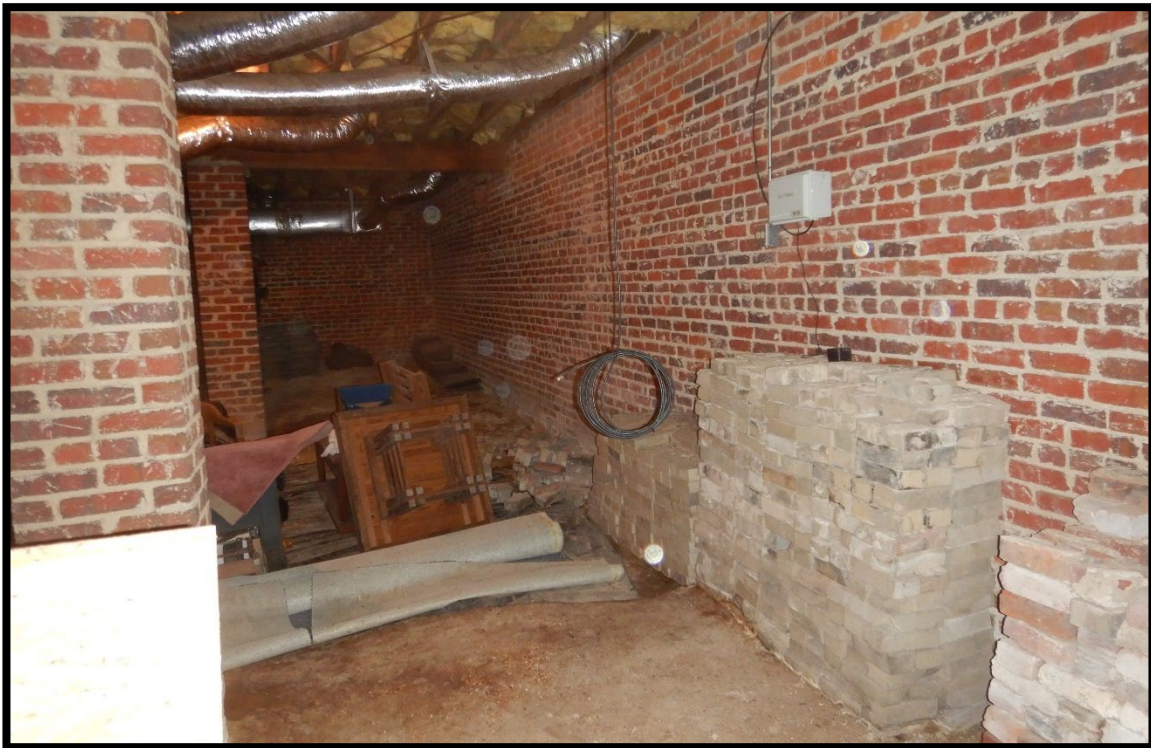
Photo #16 - This is the foundation wall along the right side.

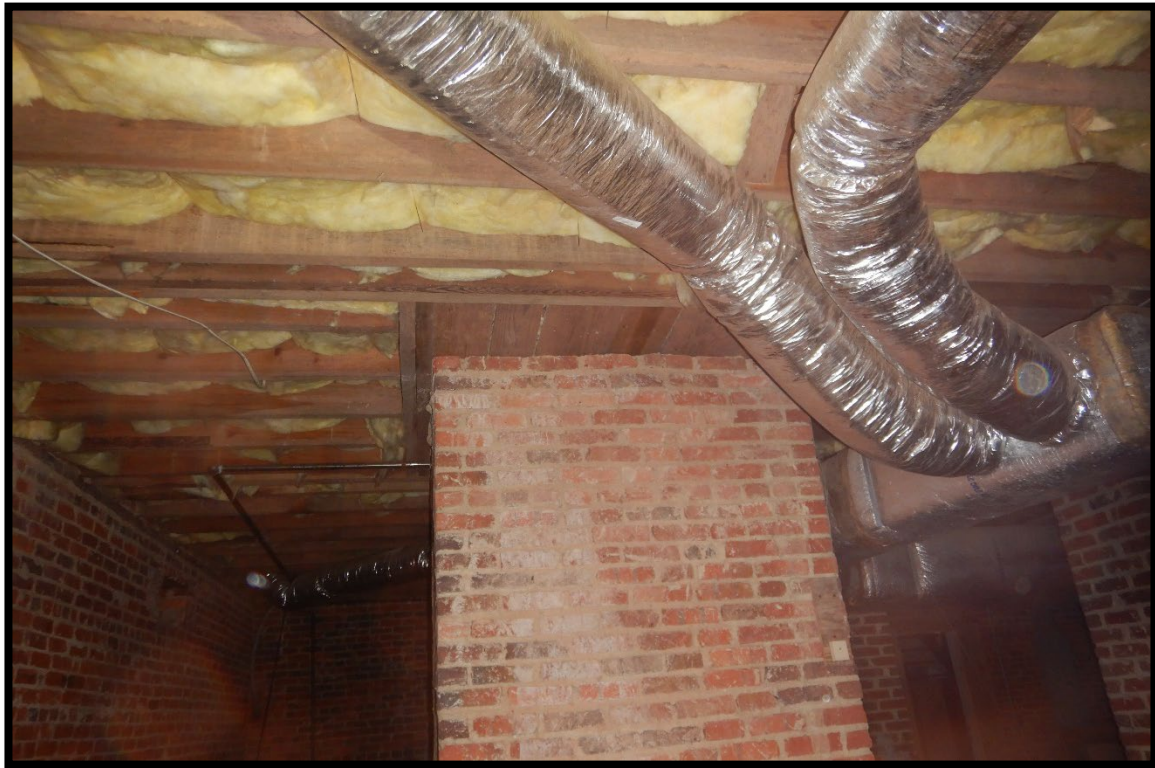
Photo #17 - This is a photo of the chimney foundation

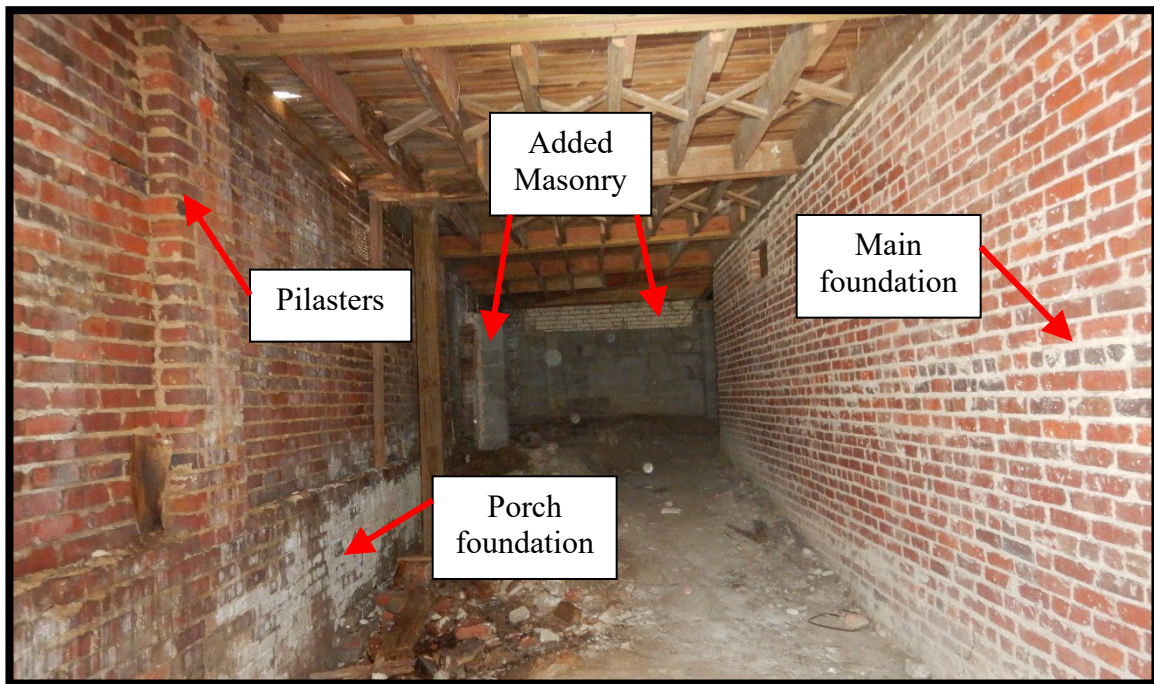
Photo #18 - This is along the right side. The main structure foundation is 12" solid brick and the porch foundation is 4" brick with pilasters and 8" foundation brick.

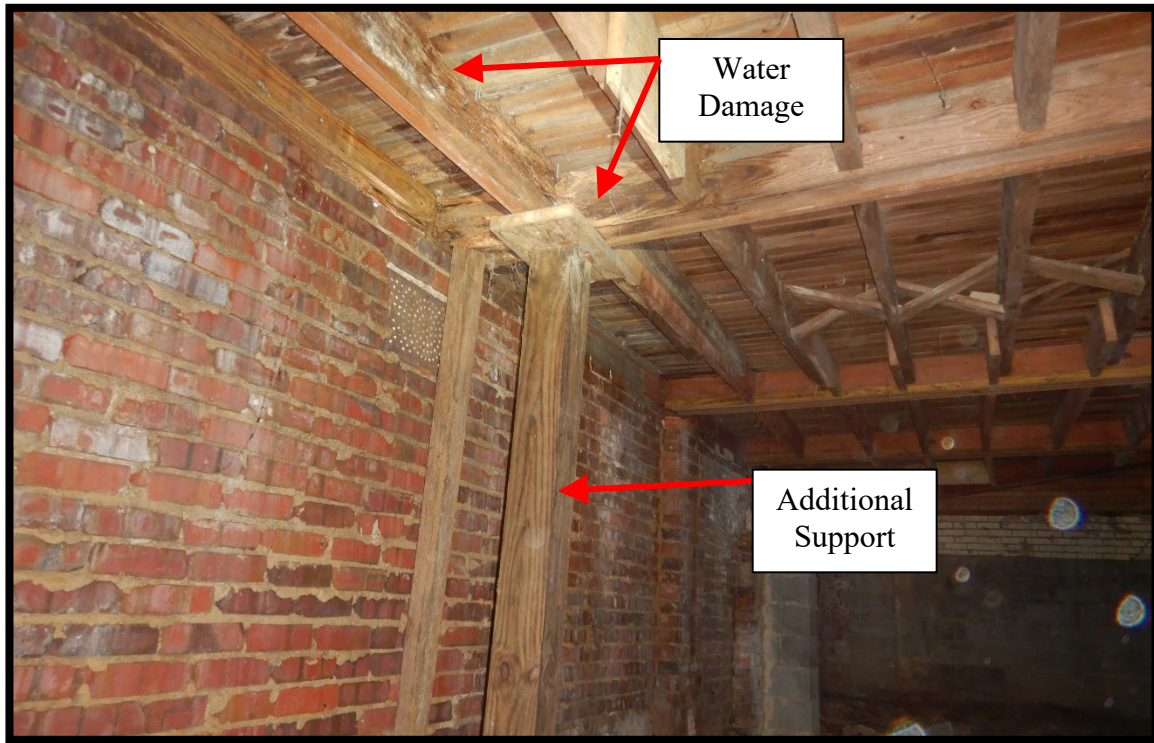
Photo #19 – Additional supports were added under some of the water damage.

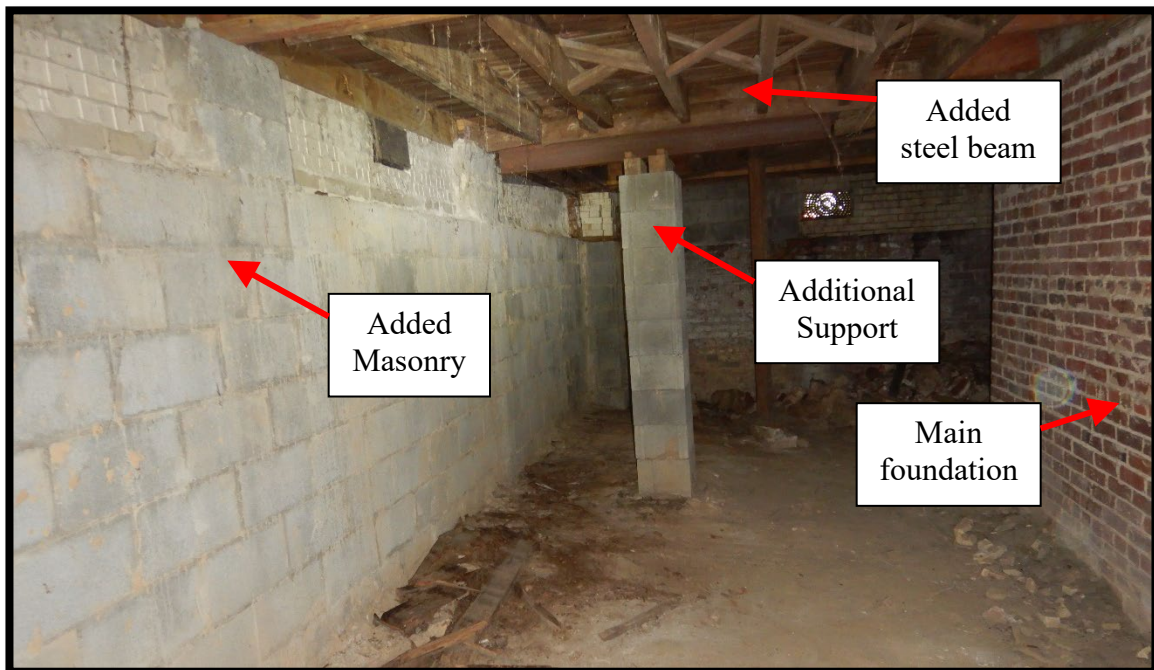
Photo #20 – Along the front porch wall additional block masonry was added to the brick. The owner stated that about 30 years ago there was a heavy rain that damaged the front wall, so it was reinforced.

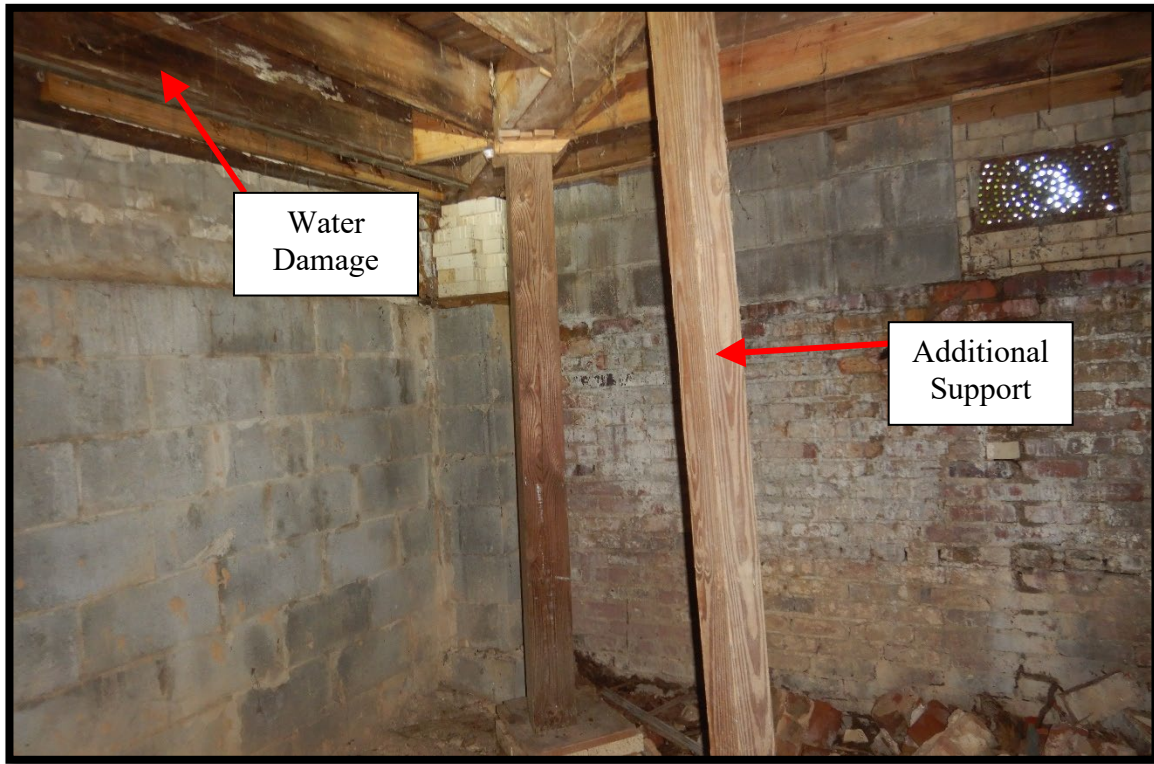
Photo #21 – Additional support added at the front left corner under water damage.

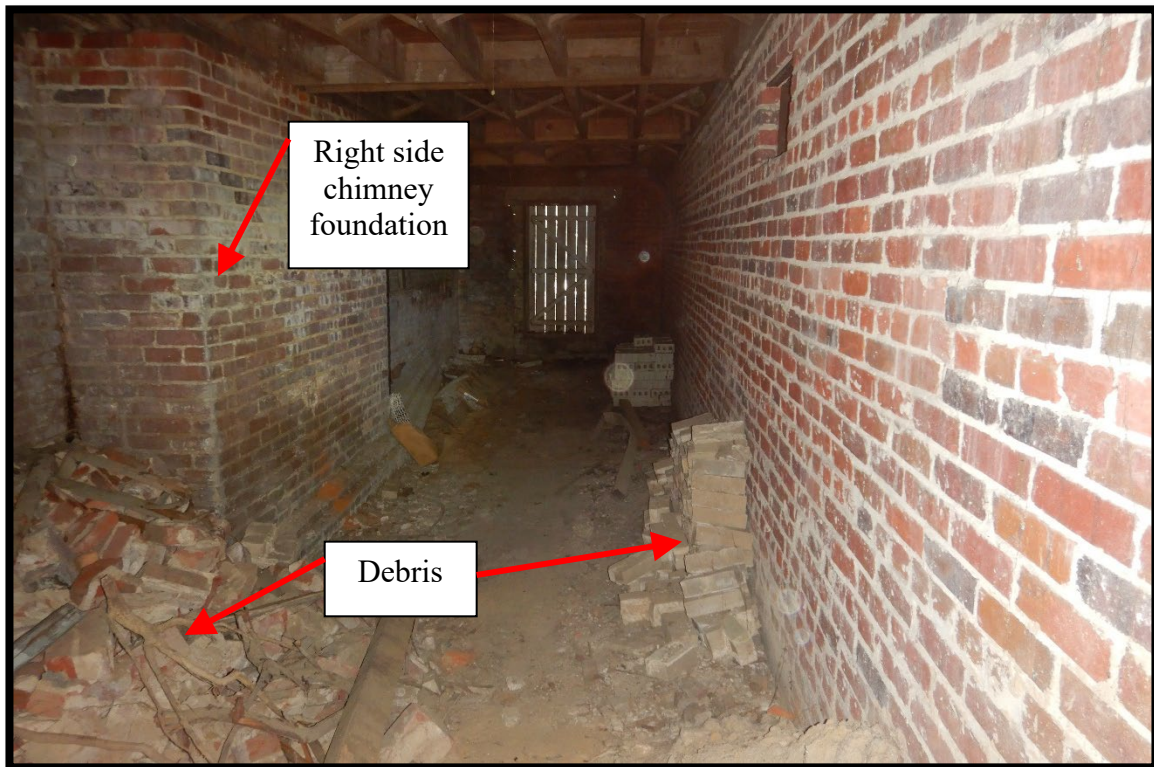
Photo #22 - This is the other end of photo 18. There is a lot of debris.

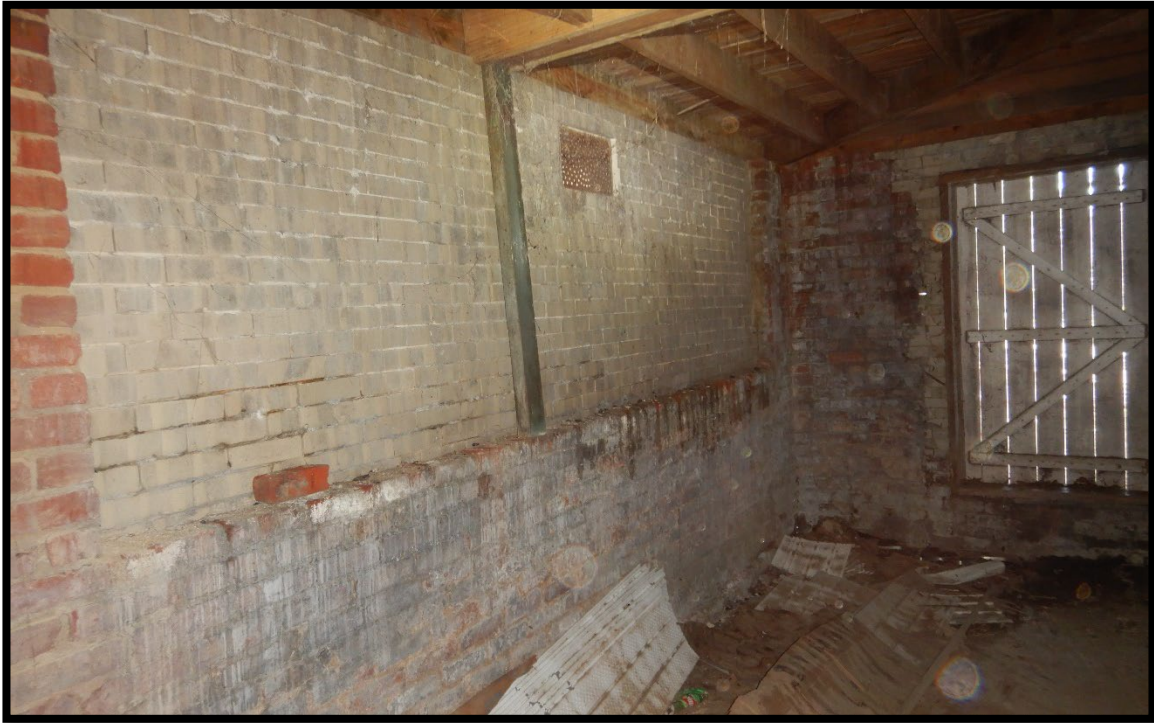
Photo #23 - This is the inside at photo 3. The brick is single wythe.

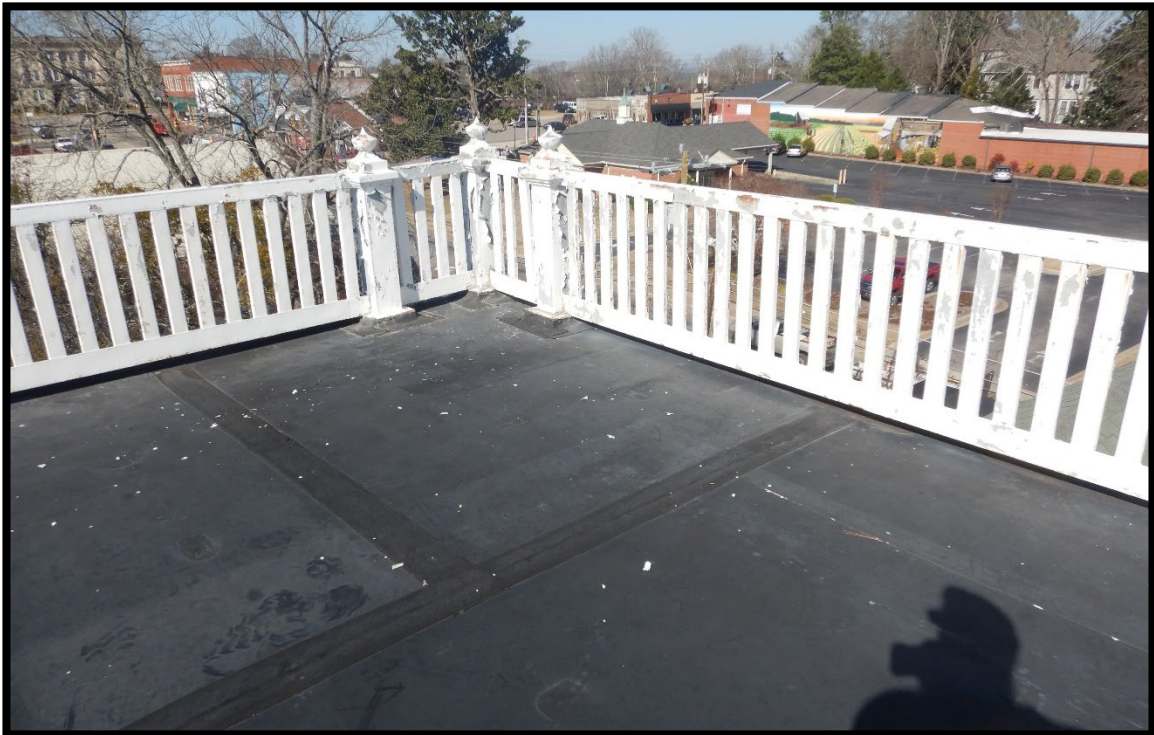
Photo #24 - Top roof railing.

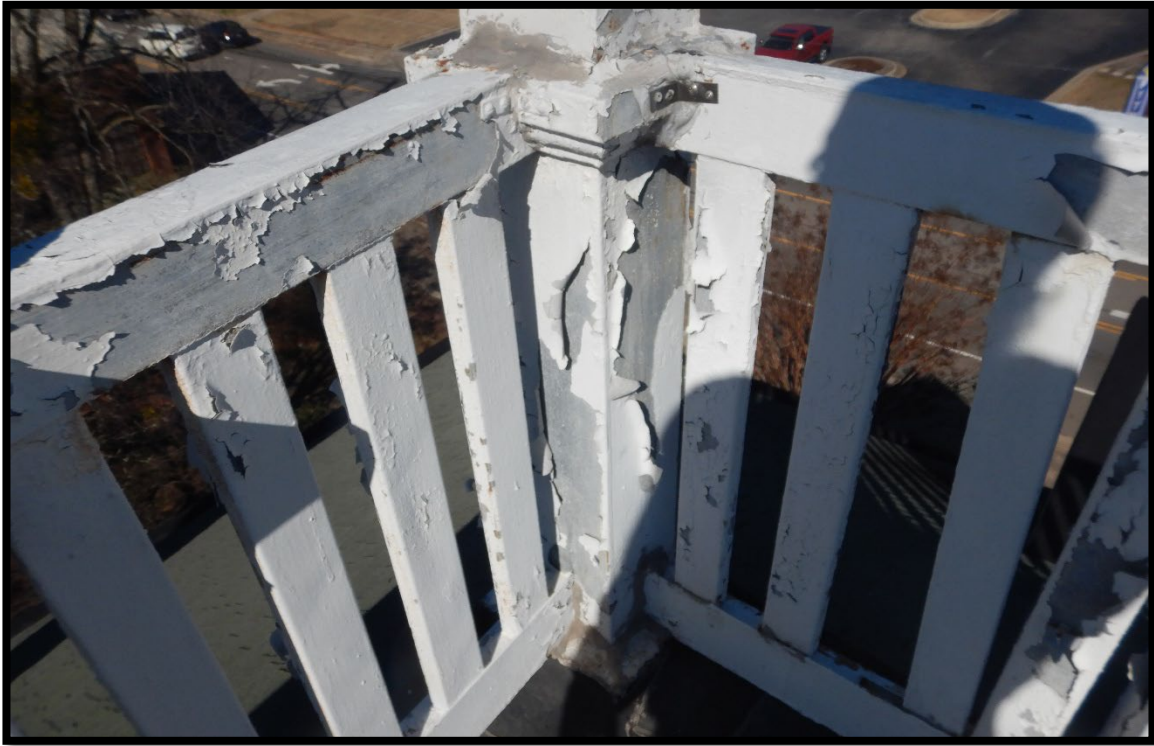
Photo #25 – Closeup of railing showing peeling paint.

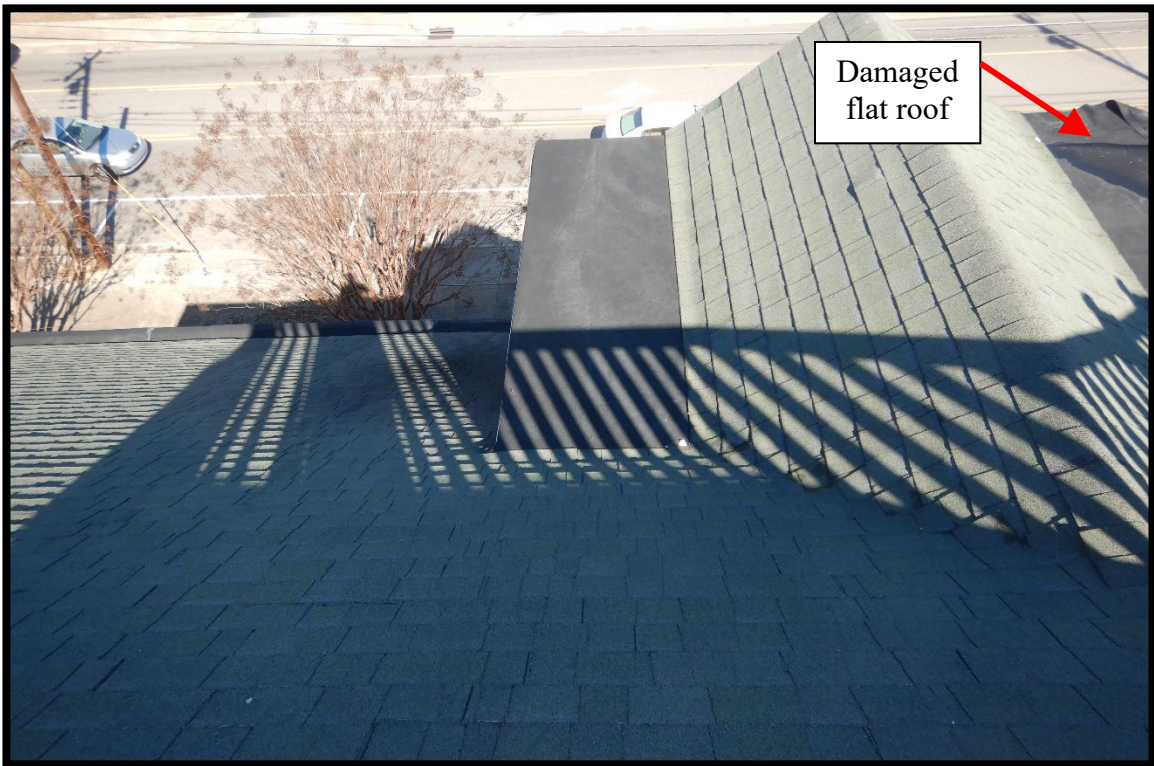
Photo #26 – There is damage to the front flat roof.

The front gable should be replaced and enlarged to get rid of the small flat areas if allowed by historic preservation.
