Neal Smith Engineering, Inc.

February 15, 2024

Subject: **Structural Inspection**
208 Monroe Street
Carthage, North Carolina
NSE Project #2400511

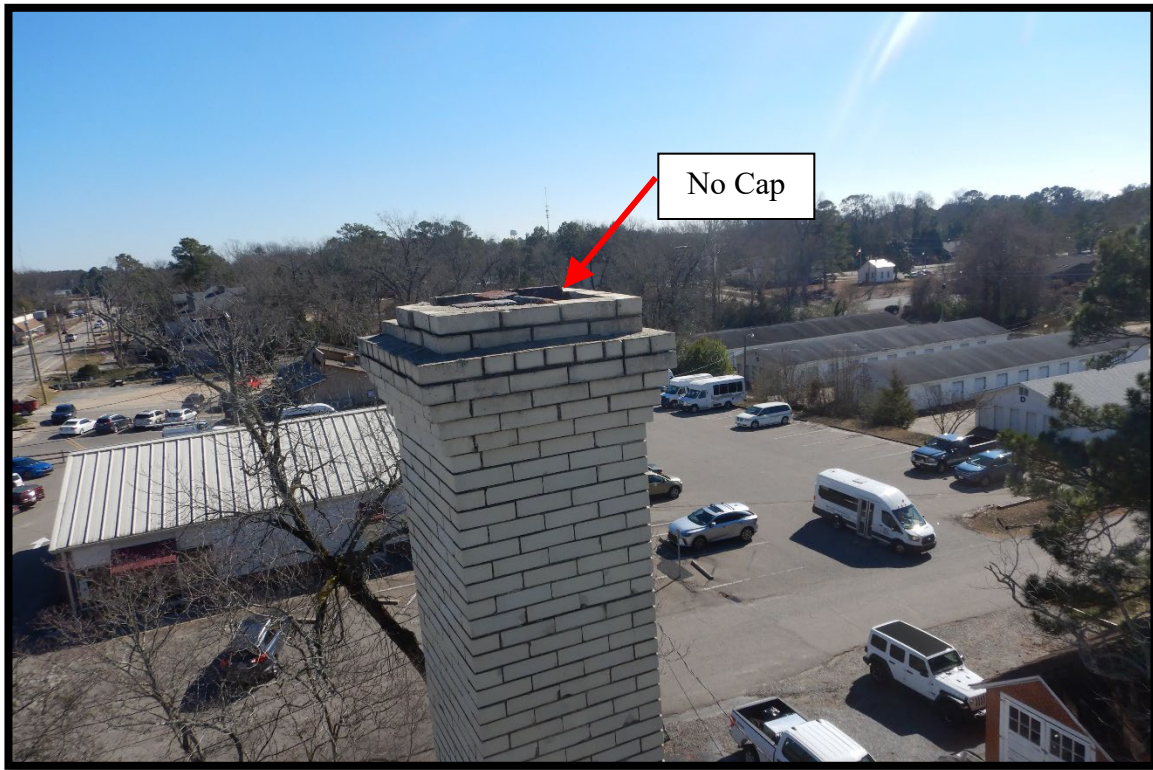
Photo #27 – There were no caps on the top chimneys.

The chimneys should be capped to prevent water from entering.

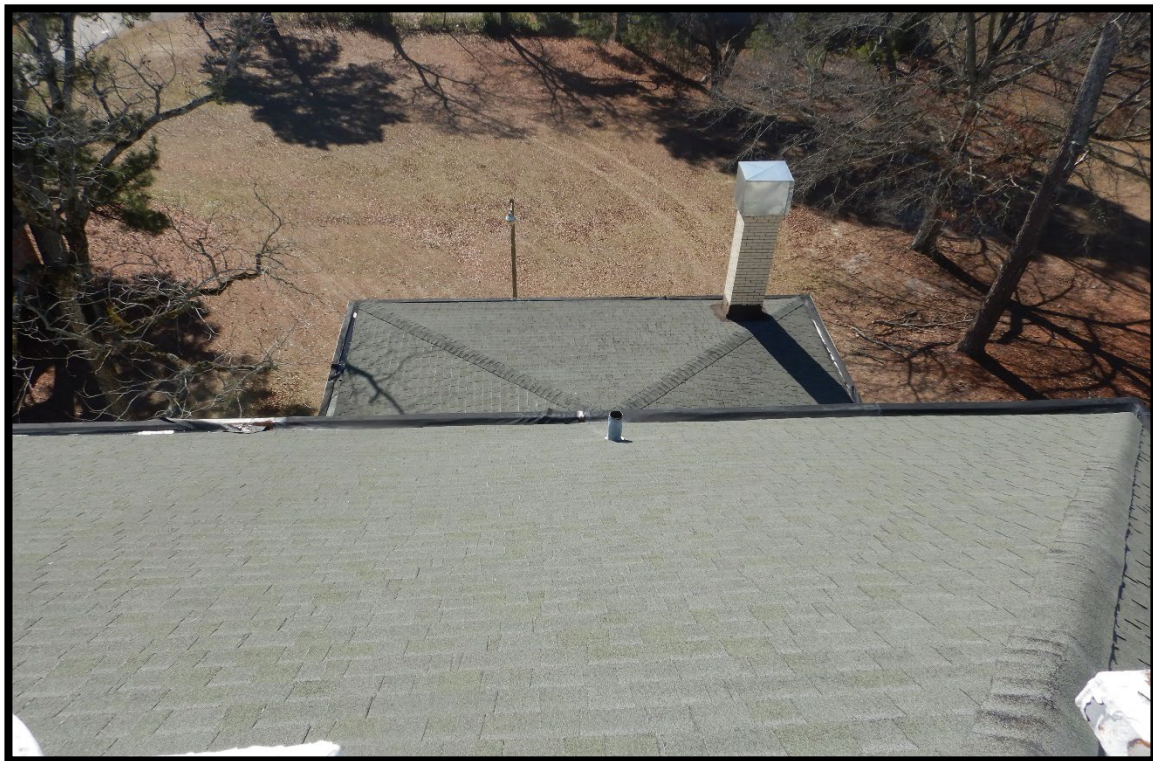
Photo #28- There was a cap on the lower rear chimney.

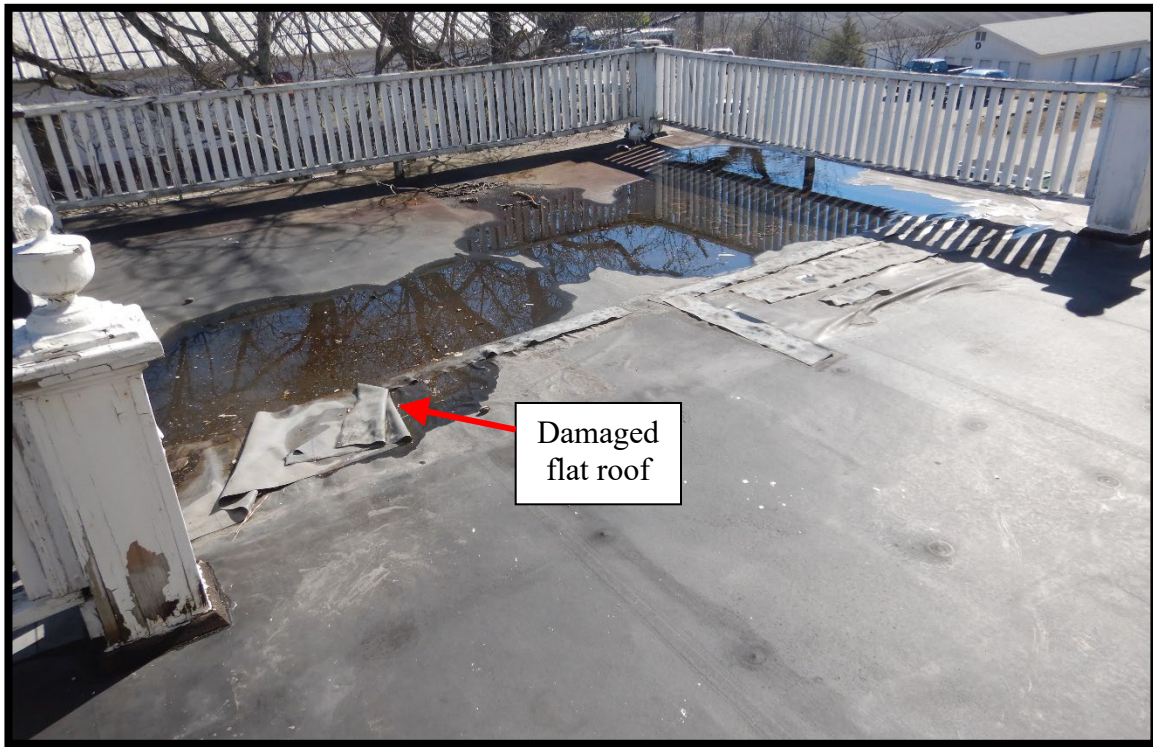
Photo #29 – Ponding water and damaged roof over the left porch cover in photo 10.

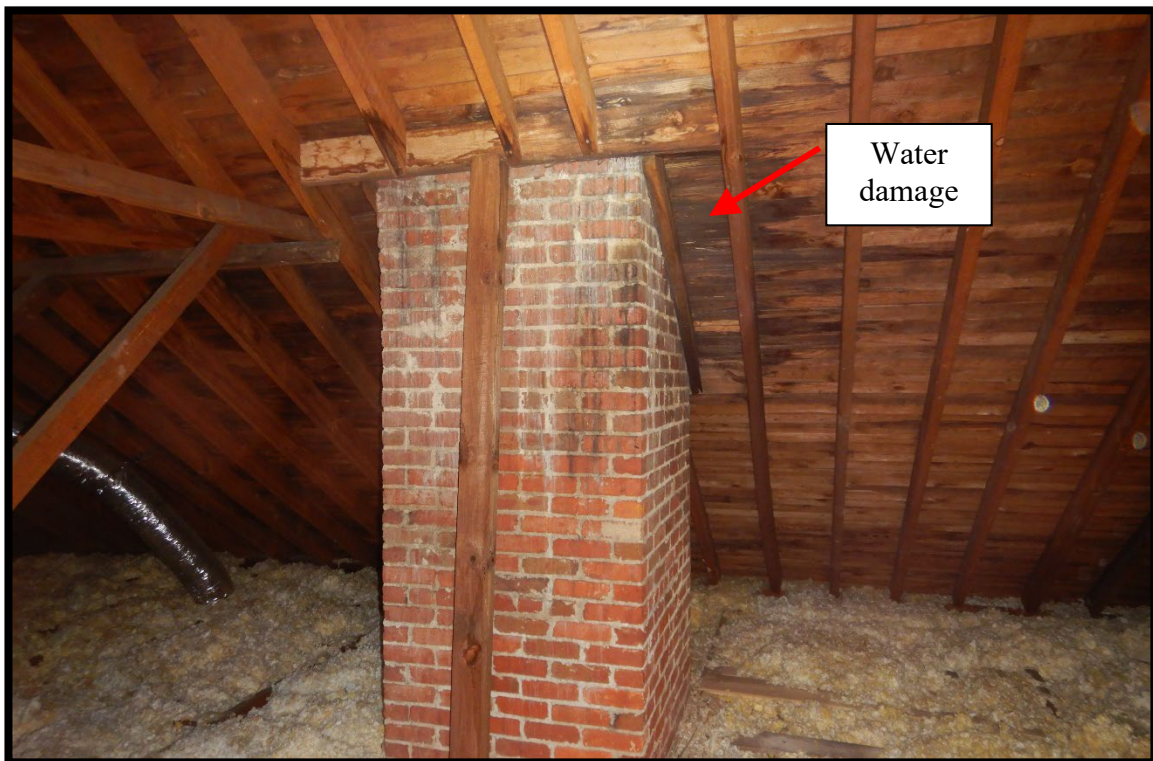
Photo #30 – Roof water damage around the left chimney.

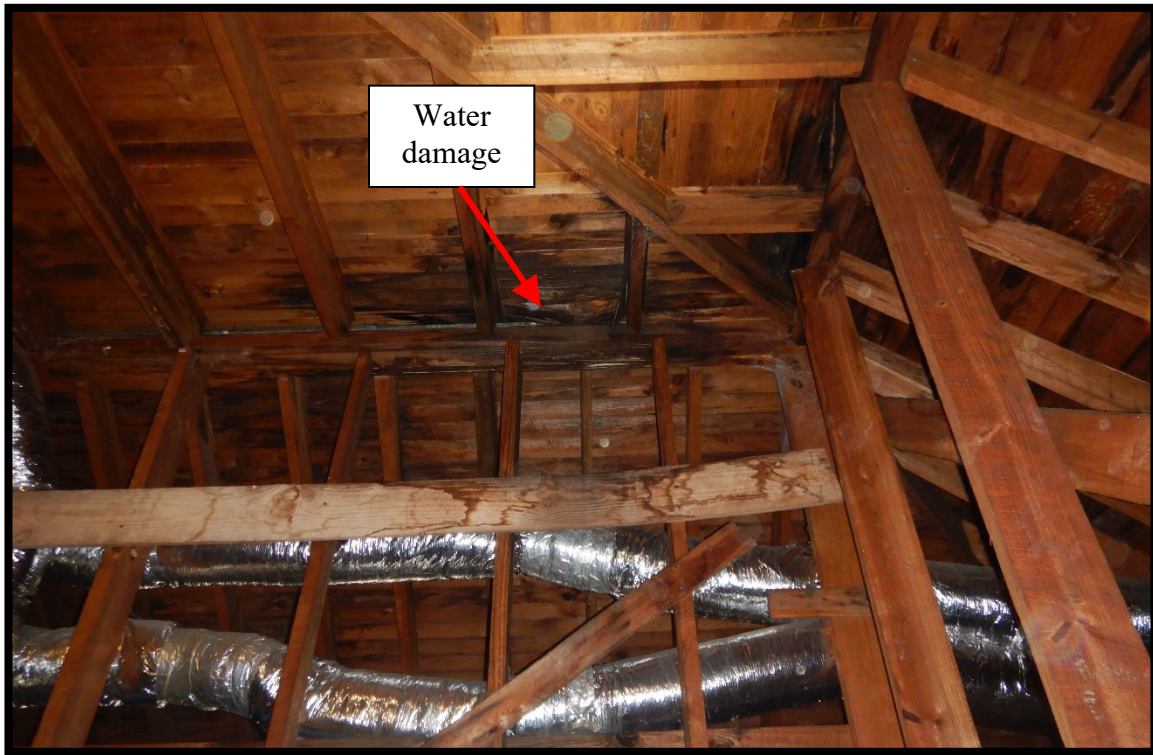
Photo #31 – Water damage under the top roof. It appears to be active.

This structure has been neglected for decades and there is extensive water damage throughout. The entire structure needs to be reroofed. Water damaged roof sheathing and framing will need to be replaced. If the structure is to be saved, this is a must. Each day there will be more decay until the structure is at least dried in.

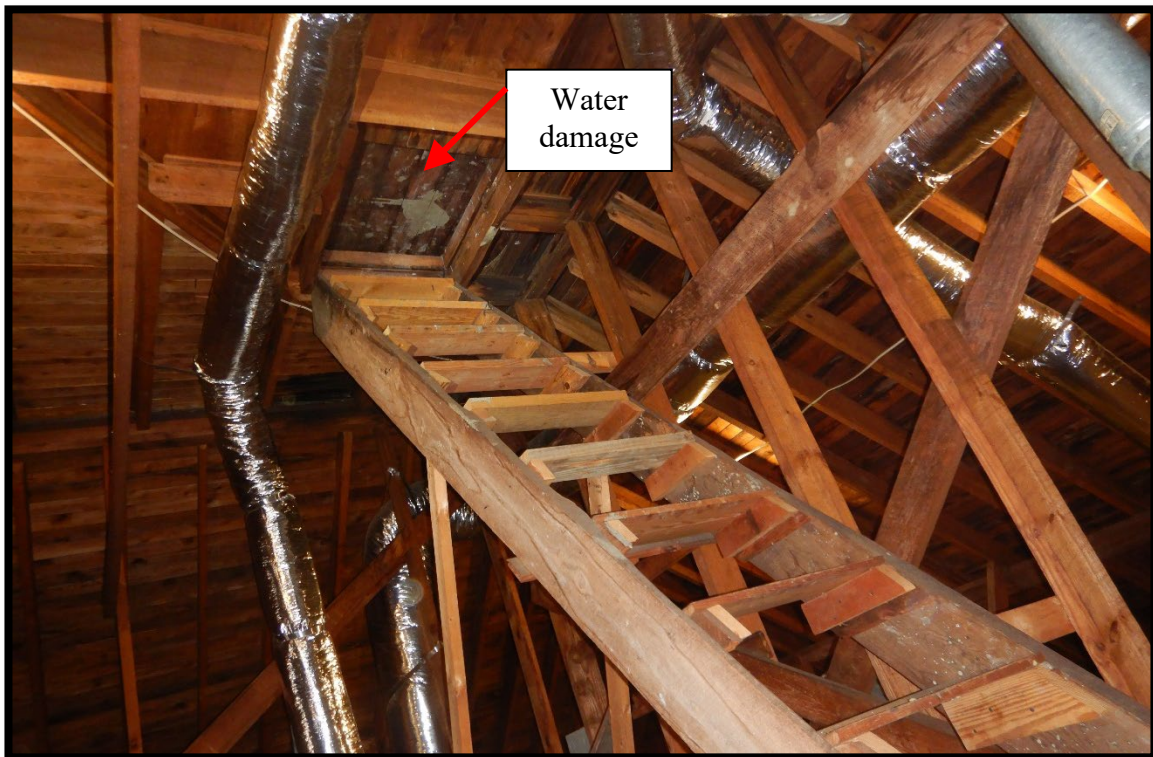
Photo #32 – Stairs to the top flat roof. The access will need rebuilding. The stairs were not safe.

The stairs to the roof and roof access hatch need to be replaced.

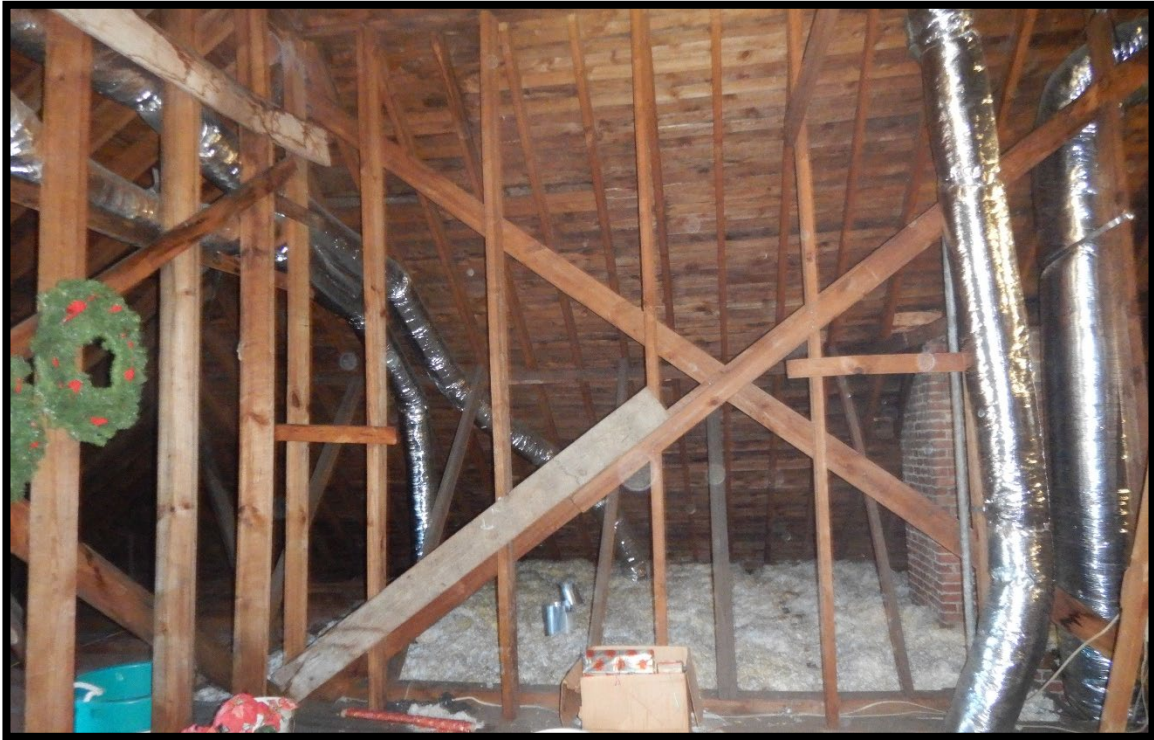
Photo #33 - This is a photo of the attic framing. The studs were all different sizes and spacings. Bracing was marginal.

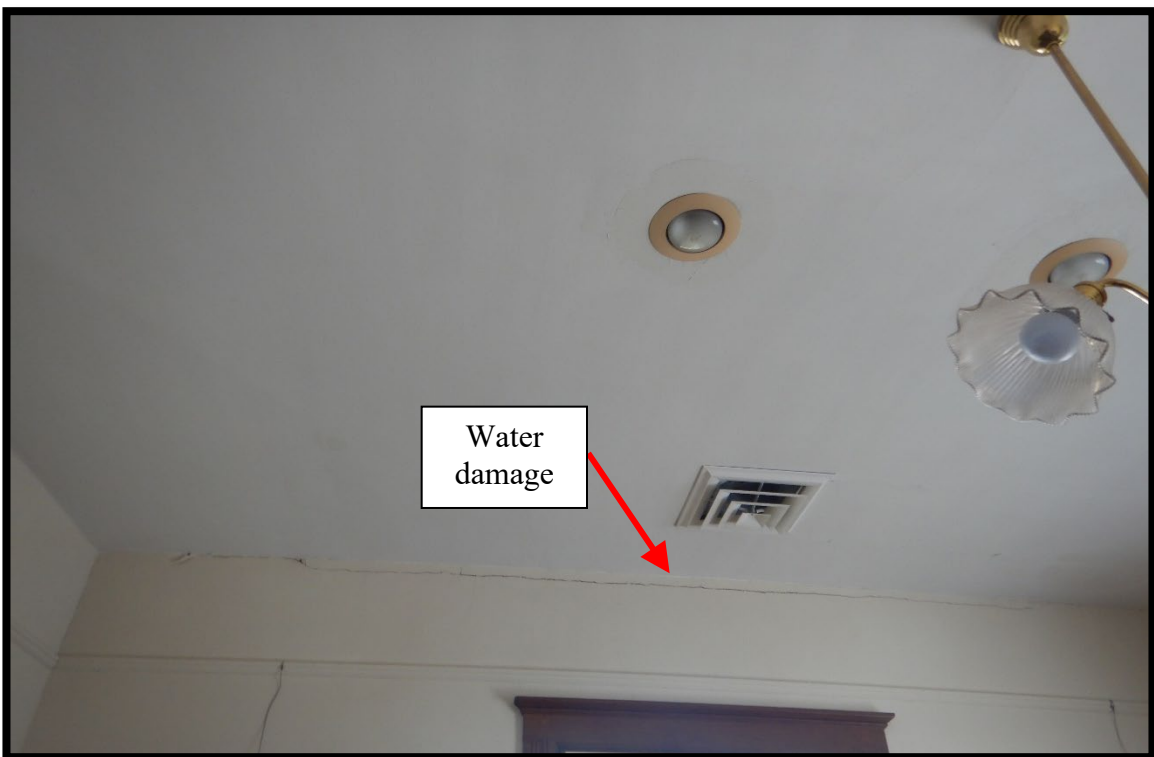
Photo #34 – Large crack in the stucco at the ceiling in an upstairs room.

Where there is severe cracking in the plaster, the plaster should be removed to make sure that there is no structural framing damage from water behind the plaster.

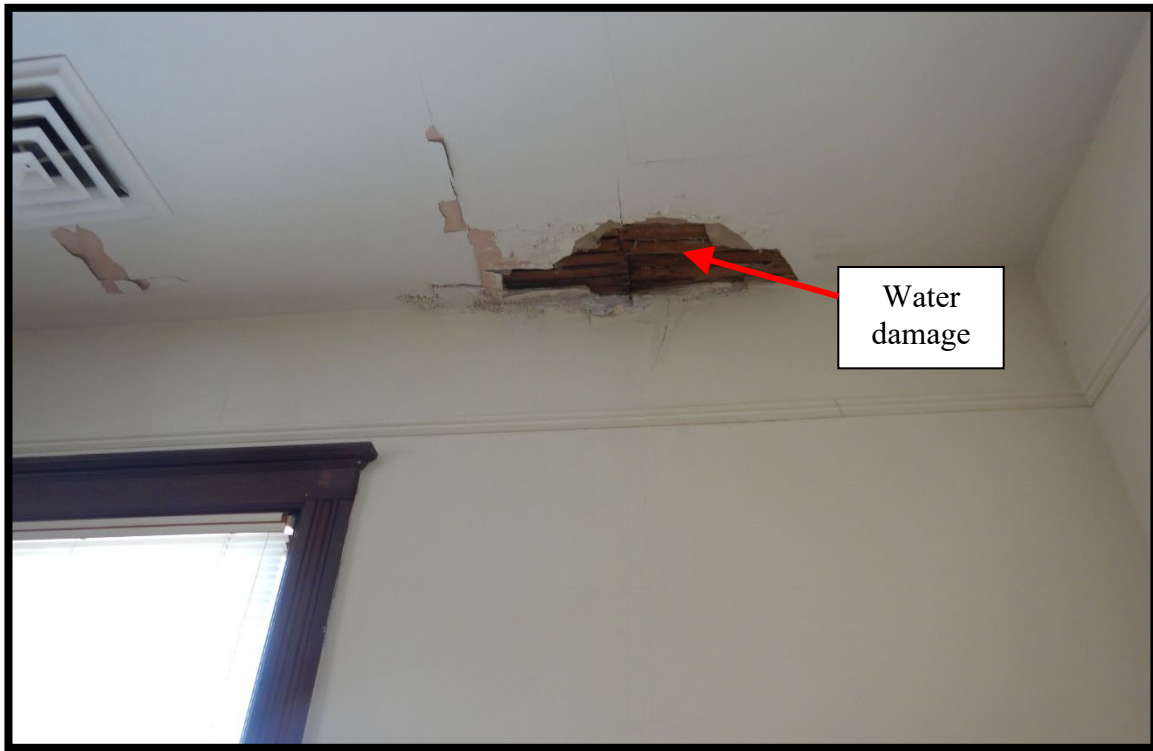
Photo #35 – Water damage in an upstairs room.

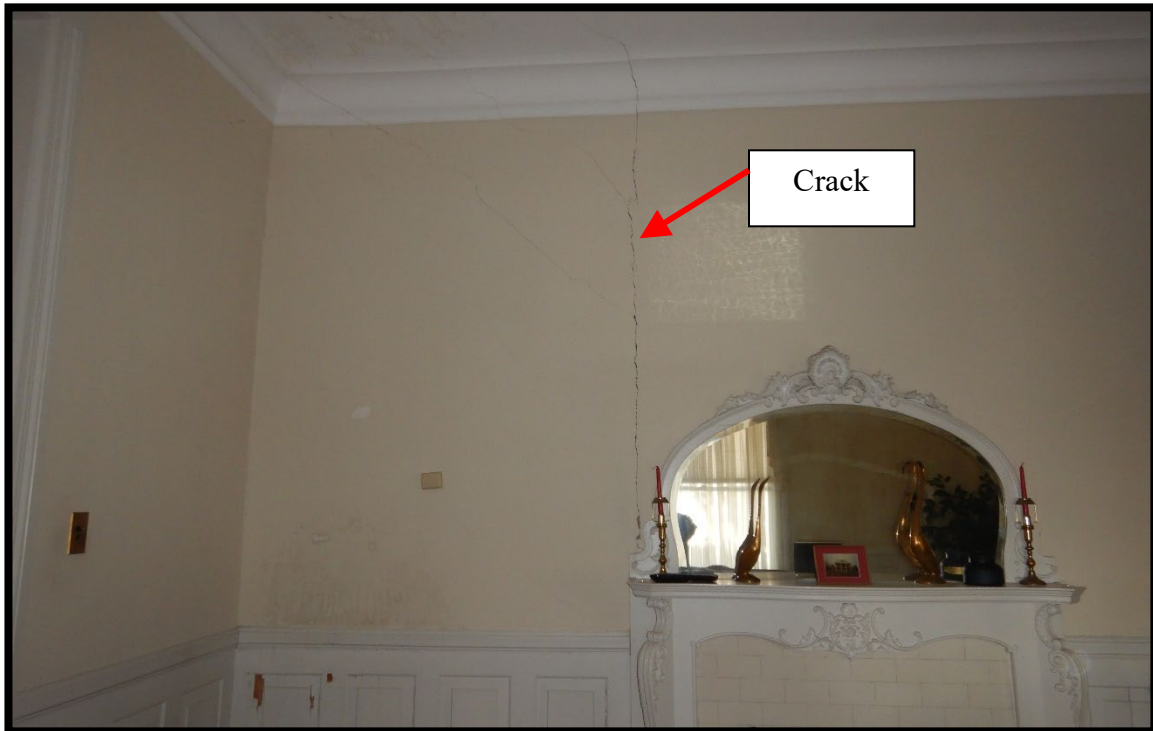
Photo #36 – Vertical crack in a downstairs room.

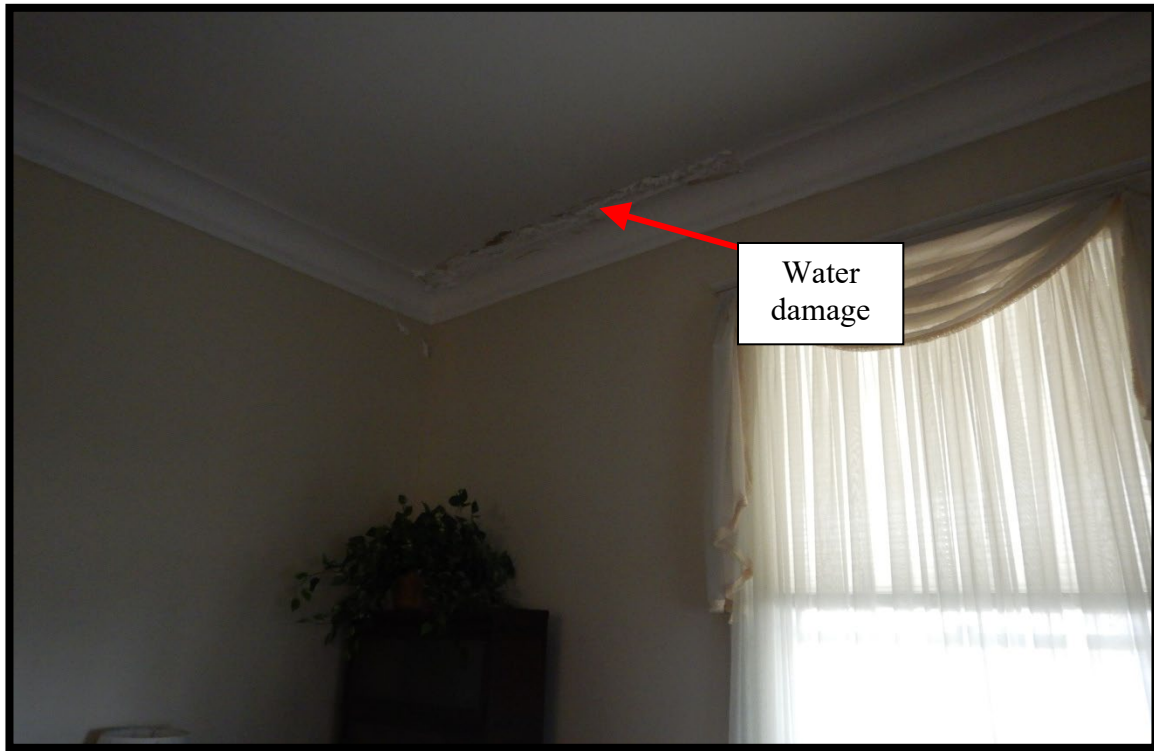
Photo #37 - This is a another photo of water damage.

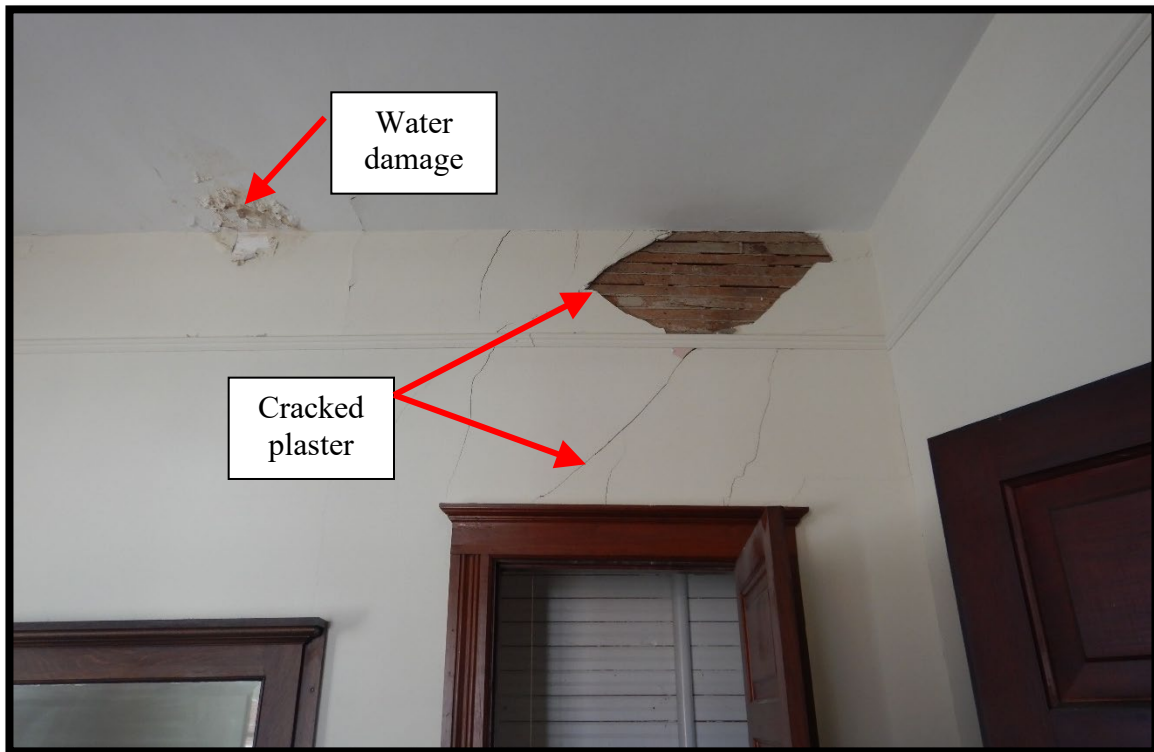
Photo #38 – Cracked plaster and water damage upstairs.

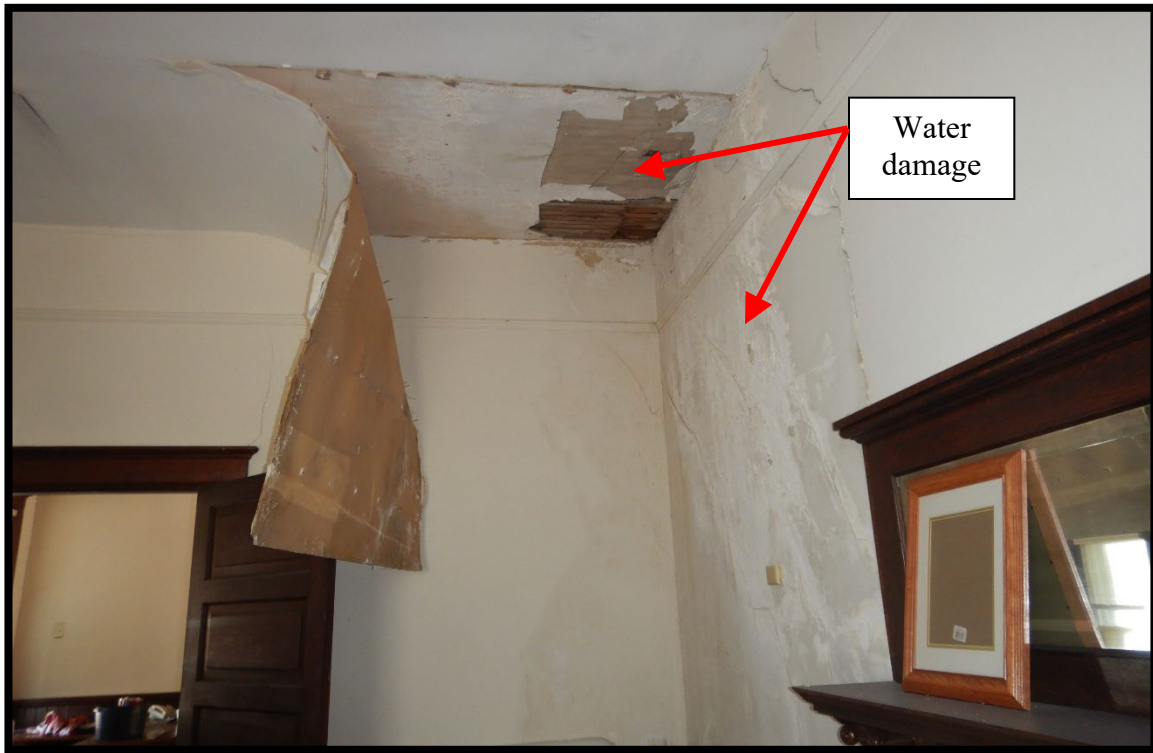
Photo #39 – Water damage downstairs, likely caused by a leaking HVAC pan.

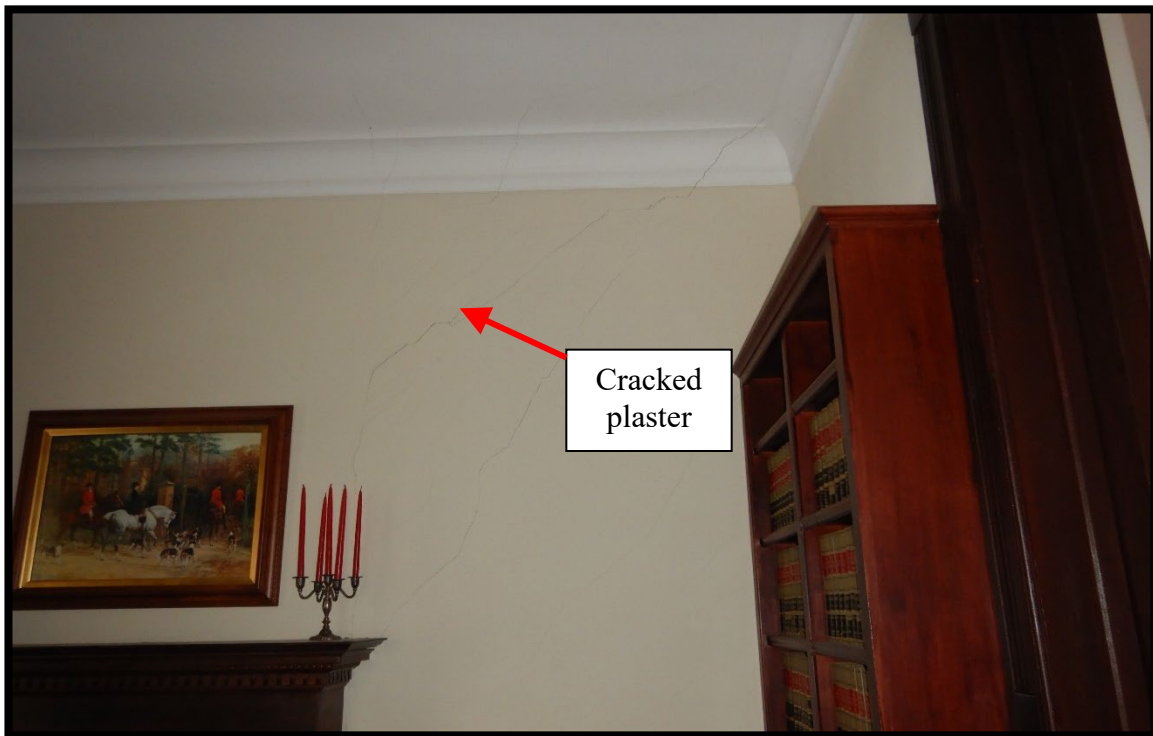
Photo #40- Plaster cracks downstairs.

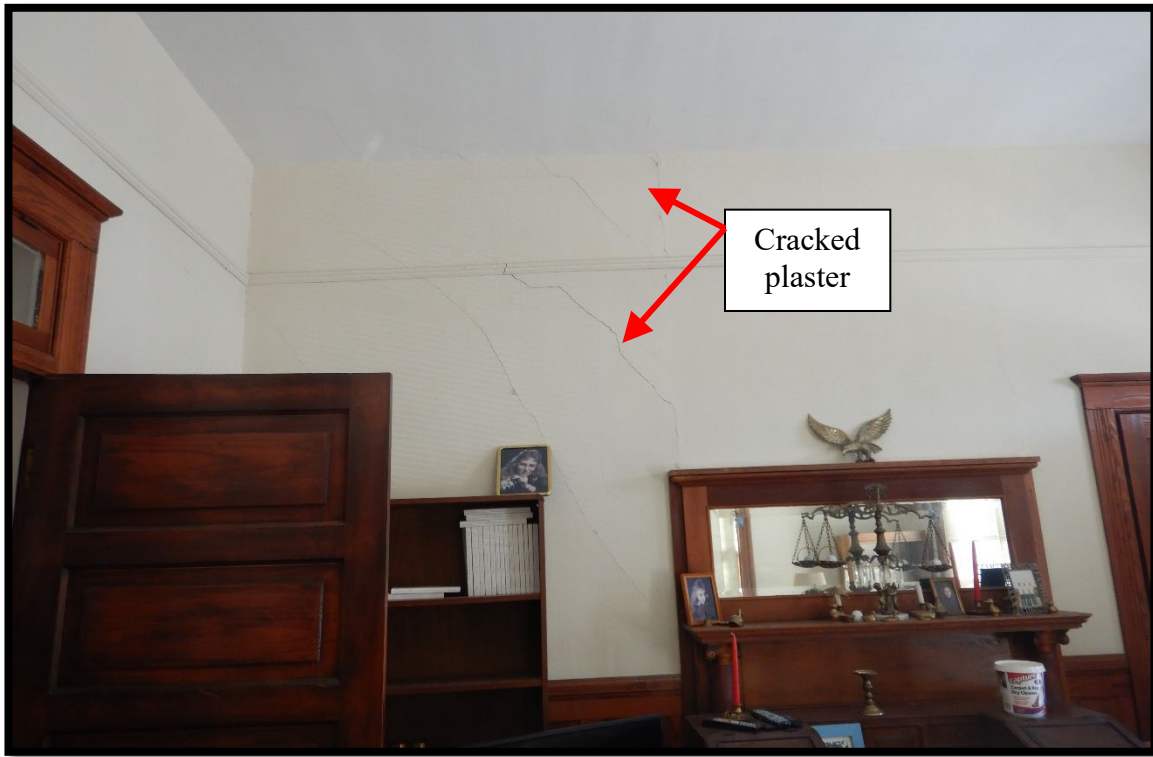
Photo #41 – More plaster cracks downstairs.

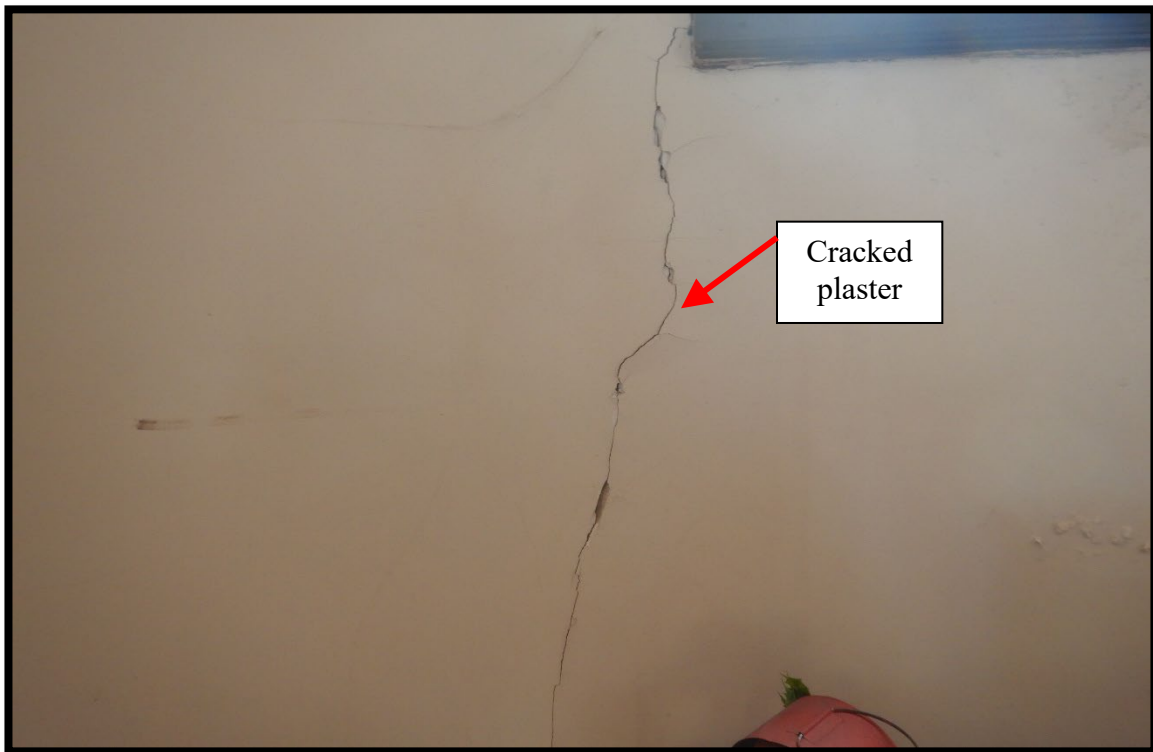
Photo #42 – Plaster cracks in the stairwell.

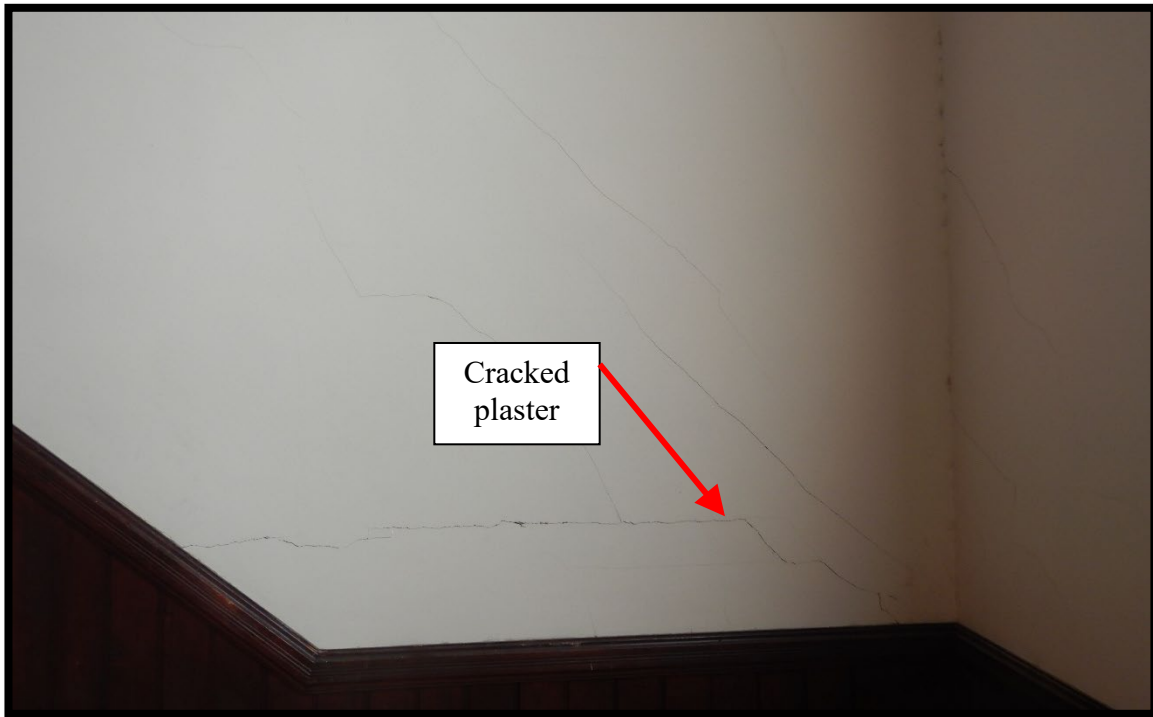
Photo #43 – More cracked plaster in the stairwell.

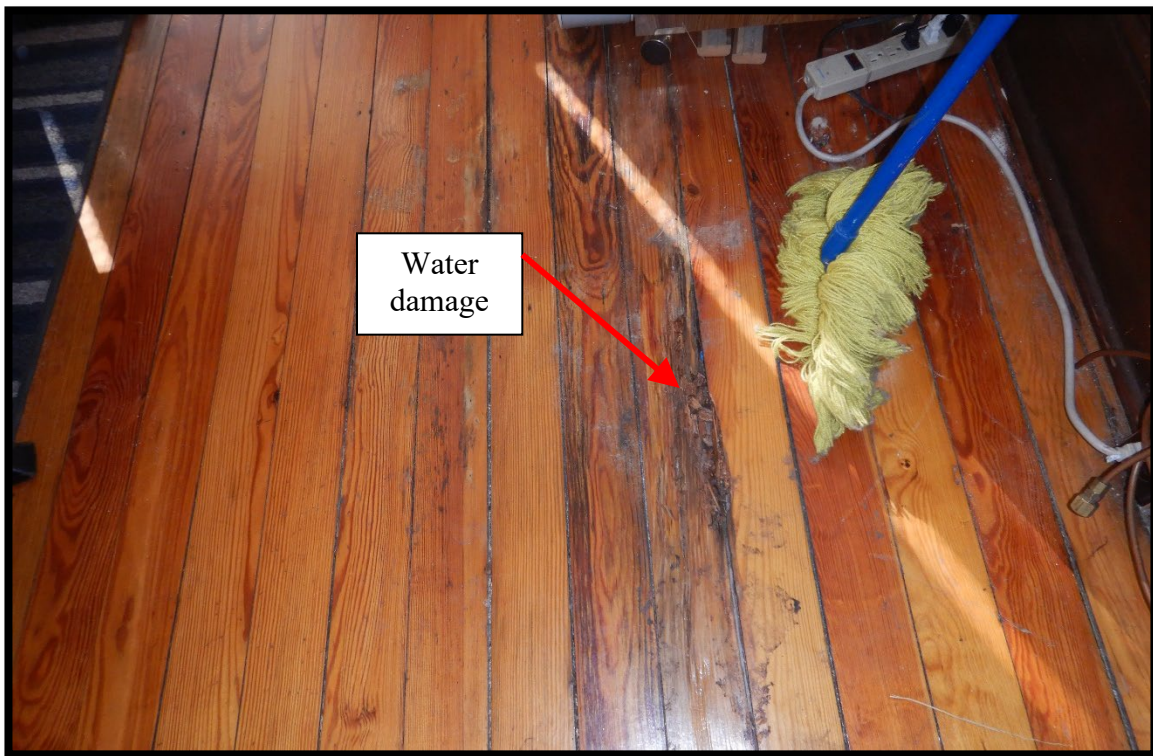
Photo #44 - This is a photo of water damaged floor.

Damaged floors should be repaired.

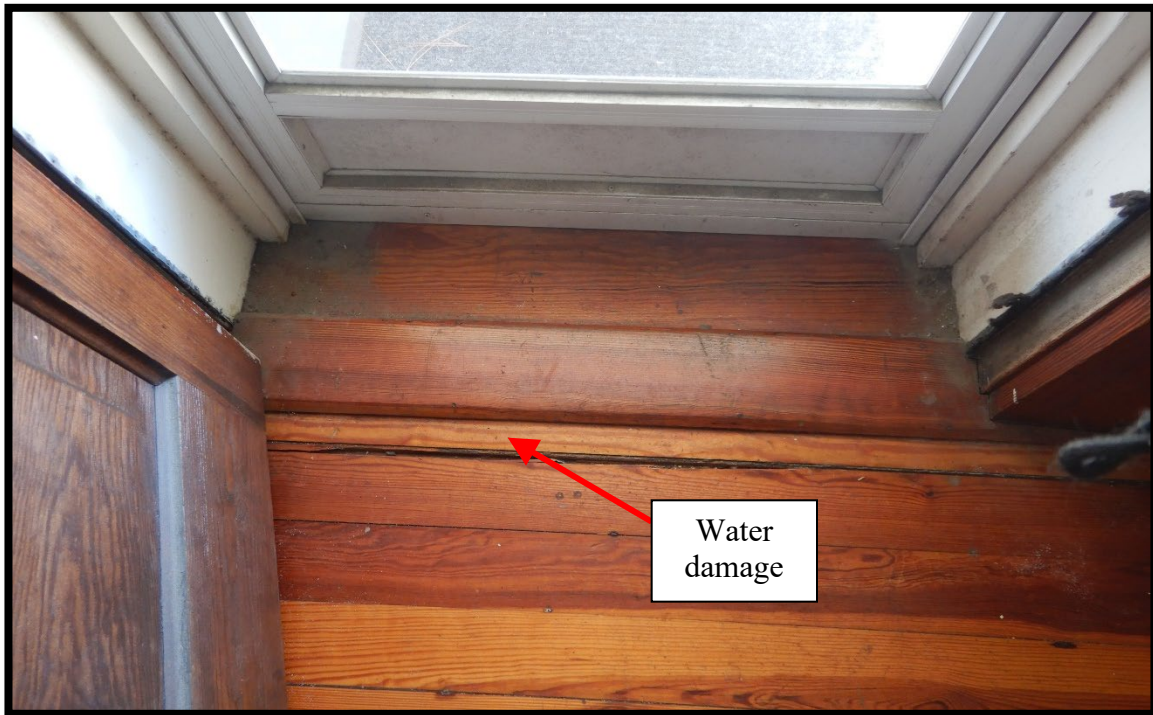
Photo #45 – Water damage at a sill plate.

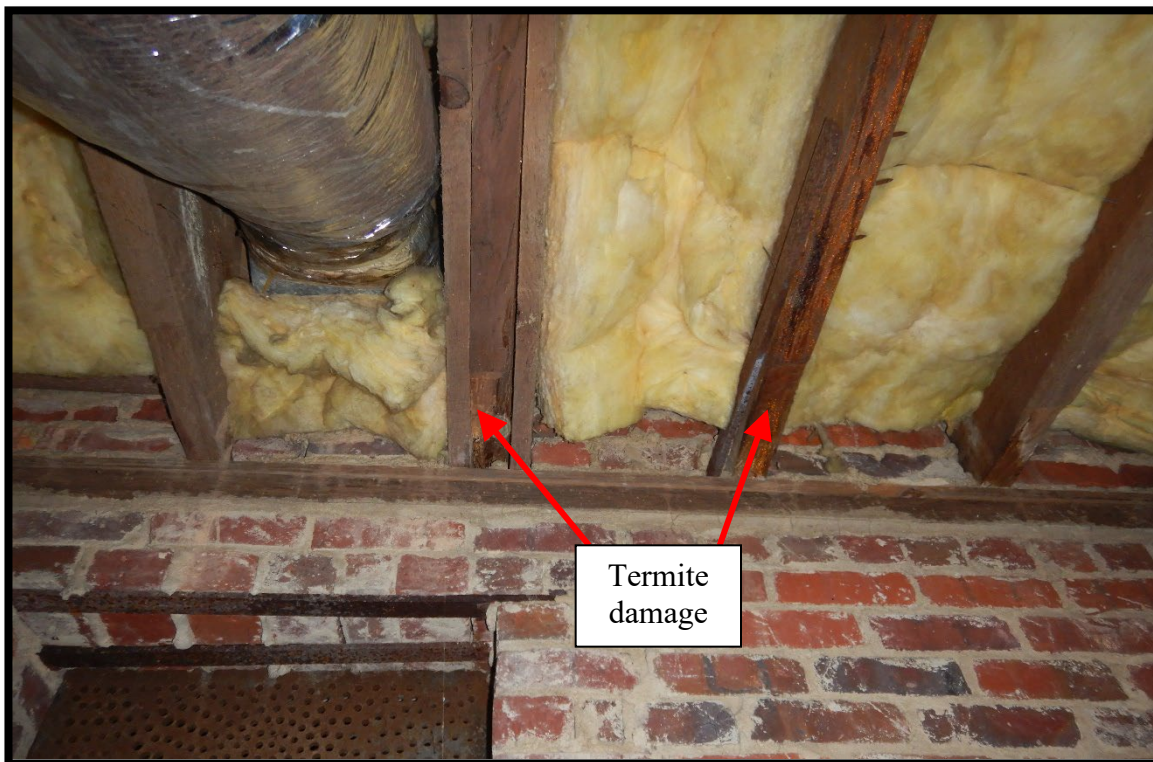
Photo #46 - This is a photo of termite damage in the basement.

The termite damage was insignificant compared to the water damage.
